**Results of 1/4-Scale Experiments.**  
**Vapor Simulant And Liquid Jet A Tests**

17 July 1998 **Revised January 28, 2000**  
Explosion Dynamics Laboratory Report FM98-6

*Prepared for and supported by the National Transportation Safety Board*

The National Transportation Safety Board (NTSB) sponsored a testing program associated with the investigation into the TWA Flight 800 accident which occurred in July of 1996. California Institute of Technology (Caltech) and Applied Research Associates, Inc. (ARA) worked together with the NTSB to perform a study of combustion within a 1/4-scale model of a 747-100 Center Wing Tank (CWT). Tests were performed with the model to examine various ignition locations, vapor concentrations, the effect of a liquid fuel layer, and the failure of the internal partitions that represented the beams and spars within the tank.

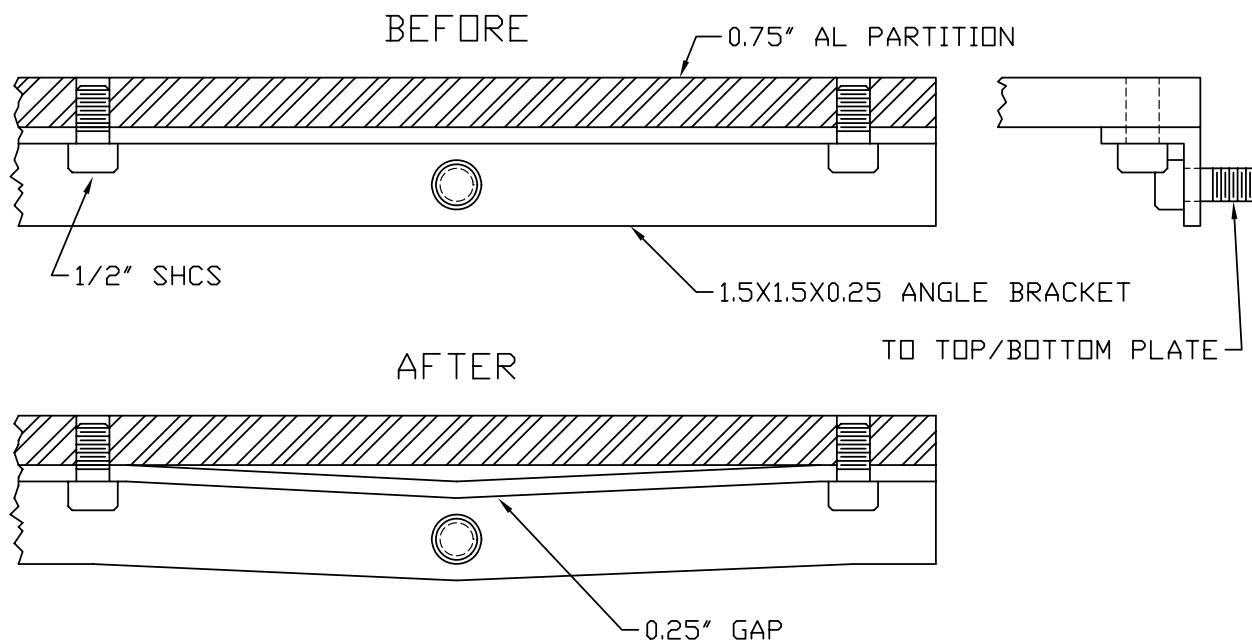
Figure 5.87: Damage to strong partition mounting brackets. View looking at top or bottom plate. Partition forced forward (toward bolts securing bracket to top/bottom plates), end of partition folded around last bolt.

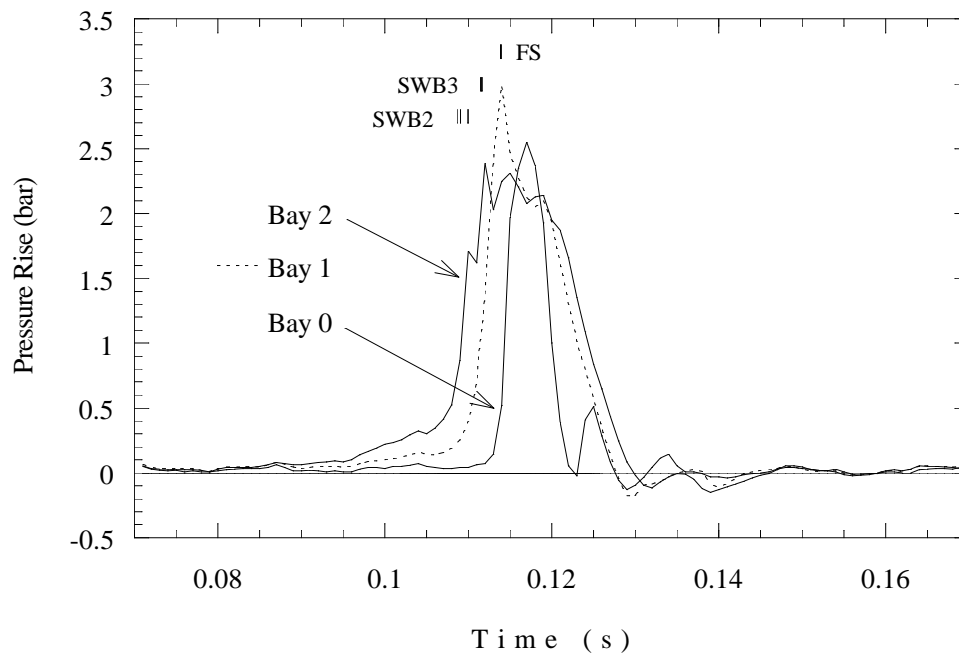
Figure 5.104: Pressure traces from bays 0 – 2, ignition in bay 5, with a cold liquid Jet A layer. Spike in bay 0 at 125 ms corresponds to failure of port side of MS. Test 19.

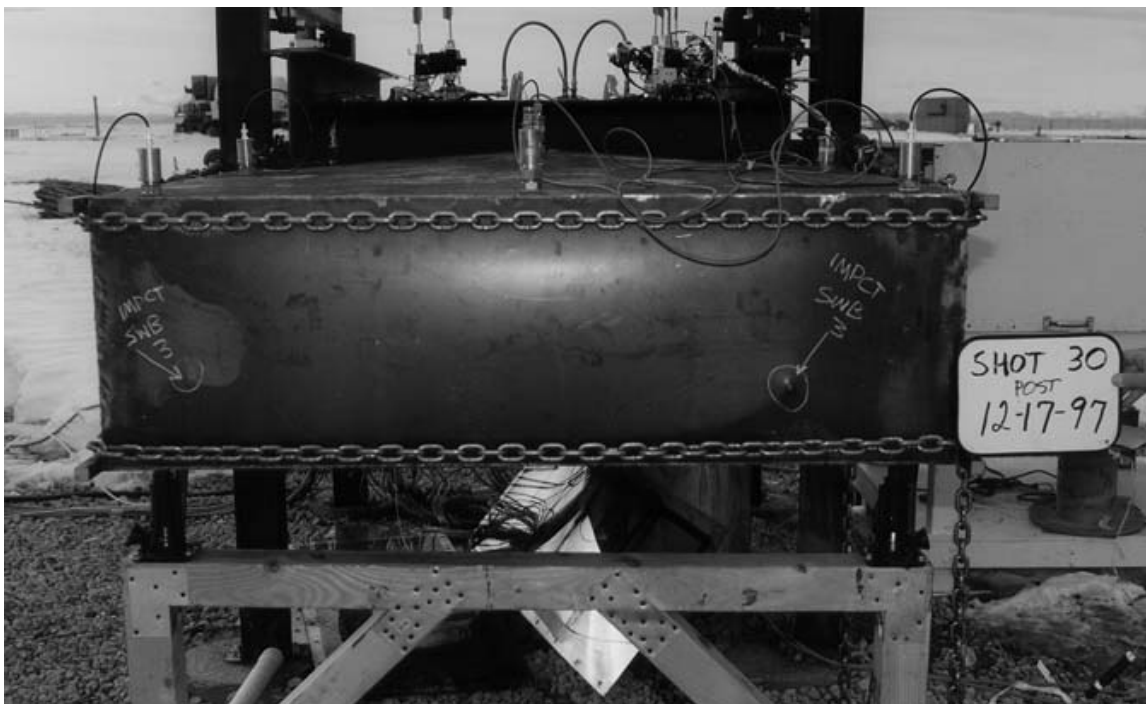
Figure 5.184: End of cargo bay after Test 30. Note that the end plate is bulged, and two dents are present from impact of SWB3. The top and bottom plates of the cargo bay are bulged out approximately 3 in at the centers of the open end.

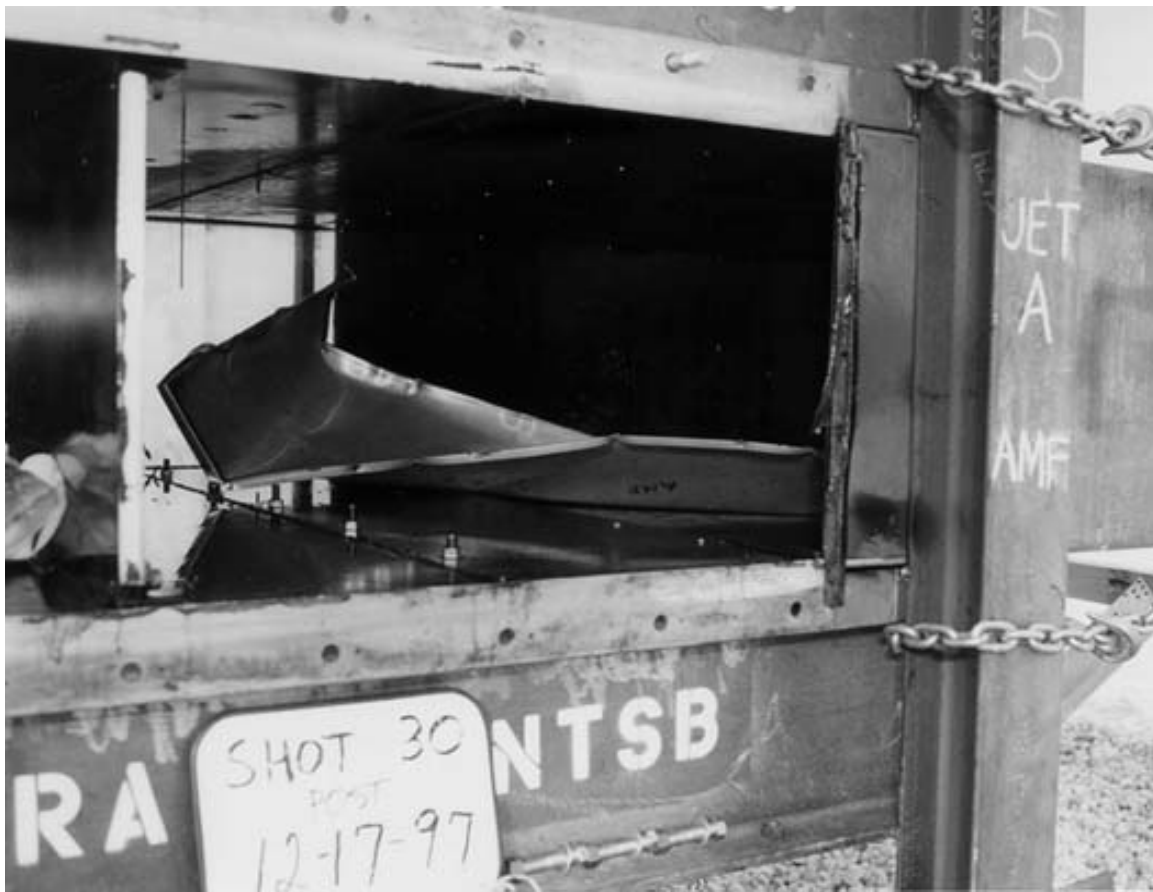
Figure 5.185: Interior of cargo bay after Test 30 (starboard window removed). SWB3 rebounded from the far end and came to rest back in the fuel tank.
