Infrared Imaging and Temperature Measurement under a Boeing 747 Center Wing Tank

Explosion Dynamics Laboratory Report FM99-3

*Prepared for and supported by the National Transportation Safety Board
Under Order NTSB12-97-SP-0127*

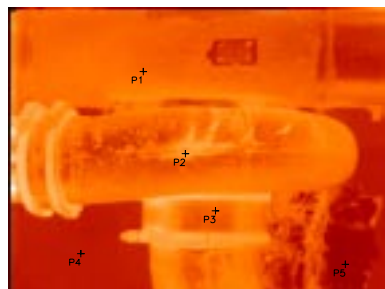
Compressor (inlet silver)
Pack 2 (d3im3)

Time	Shot #	Location in ACM bay	Emissivity	IR Temp [° F]	Handheld (EDL) [° F]	Handheld (Boeing) [° F]
	d3im1	Pack 2 Flow control valve (silver surface)	0.95	255	180	-
	d3im2	Pack 2 Rear bleed duct (grey surface)	0.95	235	174-196	-
	d3im3	Pack 2 Compressor (inlet silver)	0.95	165	135	135
	d3im4	Pack 2 Turbine	0.95	145	131	127
	d3im5	Pack 2 Fan (non metal surface)	0.95	128	100	103
	d3im6	Pack 1 Flow control valve (grey)	0.95	140	121	136
	d3im7	Pack 1 Compressor (dirty grey)	0.95	124	110	123

193.74	219.01	290.99	228.88	242.15	0.5
d3im3	157.55	168.94	156.61	145.02	137.32	0.95
	190.38	205.53	189.13	173.36	162.61	0.5
d3im4	135.1	146.17	133	157.39	132.16	0.95

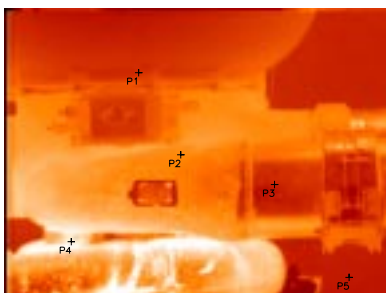
Turbine
Pack 2 (d3im4)

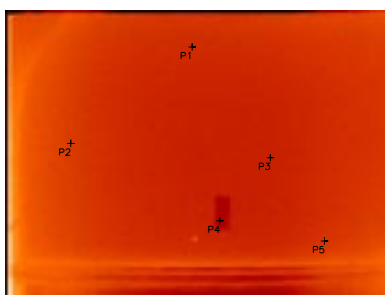
Fan
Pack 3 (d3im14)

16:35	d3im8	Pack 1 Turbine (silver)	0.95	126	110	117
	d3im9	Pack 1 Fan	0.95	111	96	101
	d3im10	Pack 3 Flow control valve (silver)	0.95	132	107	126
	d3im11	Pack 3 Bleed duct	0.95	115	101	105
	d3im12	Pack 3 Compressor	0.95	121	110	116
	d3im13	Pack 3 Turbine	0.95	116	105	114
	d3im14	Pack 3 Fan	0.95	110	98	104
	d3im15	Pack 3 Green tank bottom (beside louvres)	0.95	120	-	-

138.29	139.28	139.85	132	144.08	0.5
d3im13	118.39	123.79	117.77	120.26	120.51	0.95
	134.6	142.91	133.64	137.5	137.88	0.5
d3im14	112.01	113.66	111.94	109.14	113.6	0.95

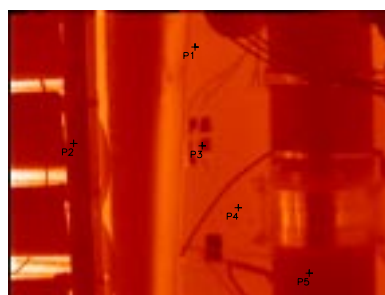
Green tank bonttom beside louvres
Pack 3 (d3im15)

124.53	127.27	124.42	119.76	127.16	0.5
d3im15	123.12	115.29	116.15	121.83	114.4	0.95
	141.92	129.8	131.13	139.93	128.42	0.5
d3im16	109.34	110.02	105.99	108.46	105.55	0.95

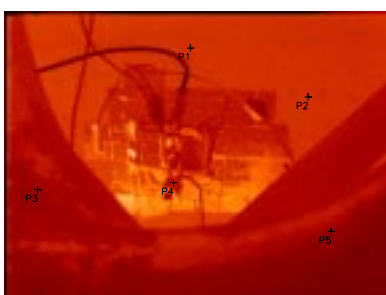
Tank bottom near Pack 1 heat exch.
radiometer (d3im16)

16:55	d3im16	Pack 1 Tank bottom near heat exchanger radiometer	0.95	188	-	-
	d3im17	Pack 1 Tank bottom beside compressor	0.95	114	-	-
	d3im18	Pack 3 Heat exchanger and tank bottom surface	0.95	113	-	-
	d3im19	Pack 3 Tank bottom (aft)	0.95	116	-	110

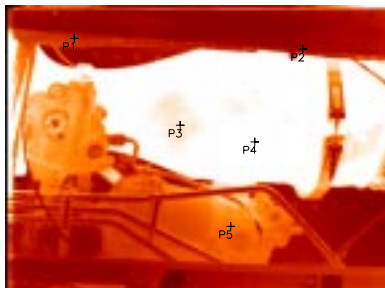
Flow control valve
Pack 1 (d4im2)

17:05	----- Packs turned on -----					
17:17	d4im1	Pack 2 Flow control valve	0.95	over-ranged	-	-
17:20	d4im2	Pack 1 Flow control valve	0.95	over-ranged	-	254

Image #	P1 [F]	P2 [F]	P3 [F]	P4 [F]	P5 [F]	Emissivity set to
d4im1	175.06	188.02	181.1	221.49	306.15	0.95
	213.44	230.13	221.25	272.16	375.85	0.5
d4im2	196.09	187.42	262.03	306.15	219.7	0.95
	240.36	229.37	321.99	375.85	269.94	0.5
d4im3	164.76	222.04	232.22	306.15	185.6	0.95
	200	272.84	285.44	375.85	227.05	0.5
d4im4	208.77	234.23	174.98	231.11	242.81	0.95
	256.31	287.93	213.34	284.07	298.43	0.5
d4im5	306.15	306.15	213.93	183.07	255.57	0.95
	375.85	375.85	262.8	223.79	314.07	0.5
d4im6	306.15	194.07	203.19	211.53	172.39	0.95
	375.85	237.8	249.29	259.78	209.99	0.5
d4im7	124.9	125.67	124.64	125.19	125.85	0.95
	144.54	145.67	144.16	144.97	145.94	0.5
