**Results of 1/4-Scale Experiments.**  
**Vapor Simulant And Liquid Jet A Tests**

17 July 1998 **Revised January 28, 2000**  
Explosion Dynamics Laboratory Report FM98-6

*Prepared for and supported by the National Transportation Safety Board*

The National Transportation Safety Board (NTSB) sponsored a testing program associated with the investigation into the TWA Flight 800 accident which occurred in July of 1996. California Institute of Technology (Caltech) and Applied Research Associates, Inc. (ARA) worked together with the NTSB to perform a study of combustion within a 1/4-scale model of a 747-100 Center Wing Tank (CWT). Tests were performed with the model to examine various ignition locations, vapor concentrations, the effect of a liquid fuel layer, and the failure of the internal partitions that represented the beams and spars within the tank.

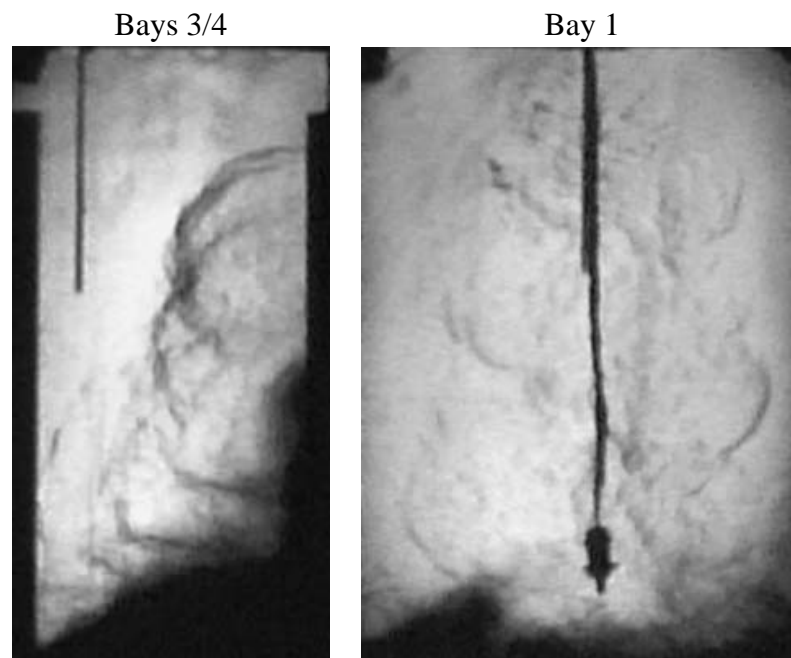
This occurs within 1 – 2 frames of ignition, which is indicated by a glow from the filament. In the frame after lofting, an orange flame is visible that fills bay 5 and is already in bays 3 and 4. By the next frame, the orange flame is present throughout the tank. The orange flame persists for the longest time in bays 1 and 5/6. The lofting and subsequent flame is also visible in footage from the SE DBM. This camera is able to capture the lofting over a few more frames, and in all three forward compartments (along the starboard side). In bay 3, it appears that the liquid fuel ignites right at the region of lofting.

Figure 5.40: Fuel lofting in Test 8.

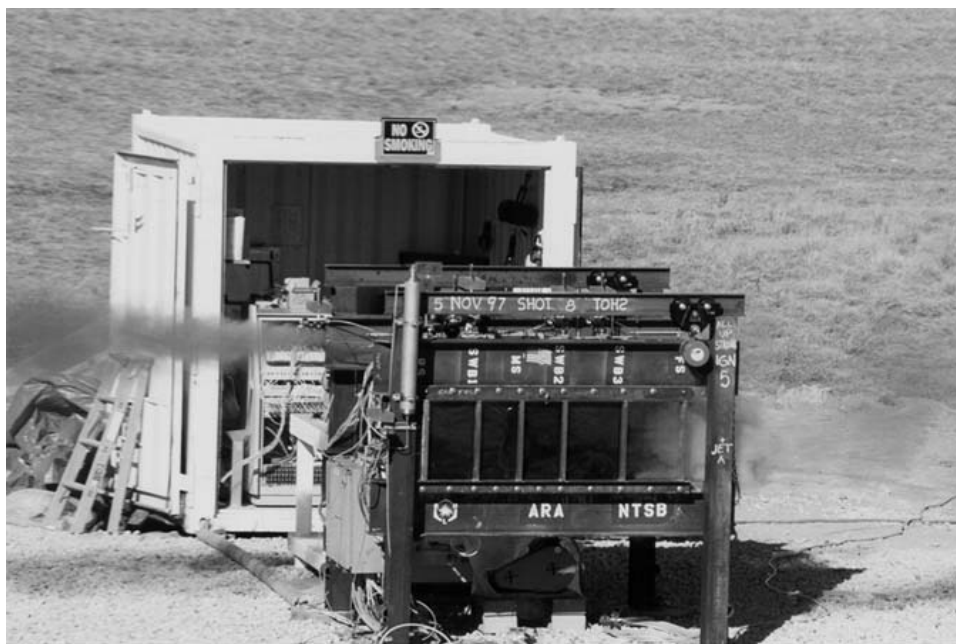
The external footage showed a fair amount of leakage around SWB3, although this may have just been enhanced by the presence of soot and smoke in the gas. The NE DBM showed the leakage to be concentrated in the bottom starboard corner of SWB3, although there was leakage on both sides. The smoke also made an excellent tracer for flow out of the vent stringer exits (Fig. 5.41), which is not normally visible. Inside the tank, a white spray of lofting at the bottom starboard corner of SWB1 can be seen on the tape from the west hilltop video camera.

Figure 5.41: Venting of combustion products from vent stringers and leaks in SWB3. The soot acts as a tracer for the flows. Test 8.

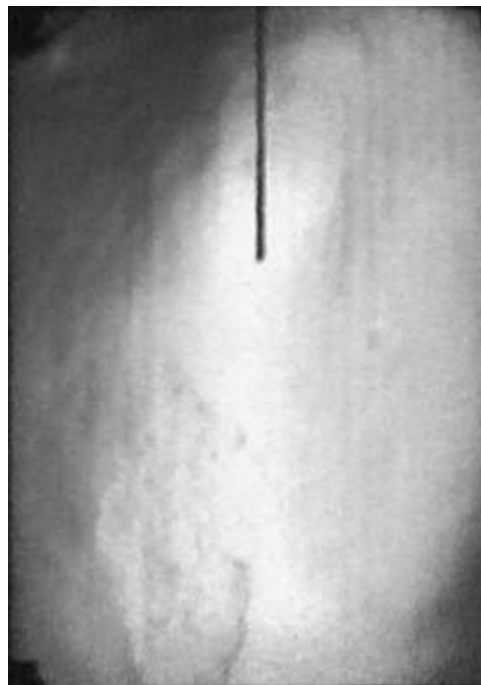
Figure 5.51: Ignition of bay 1 through jet fuel manifold in bottom of tank. Test 6.

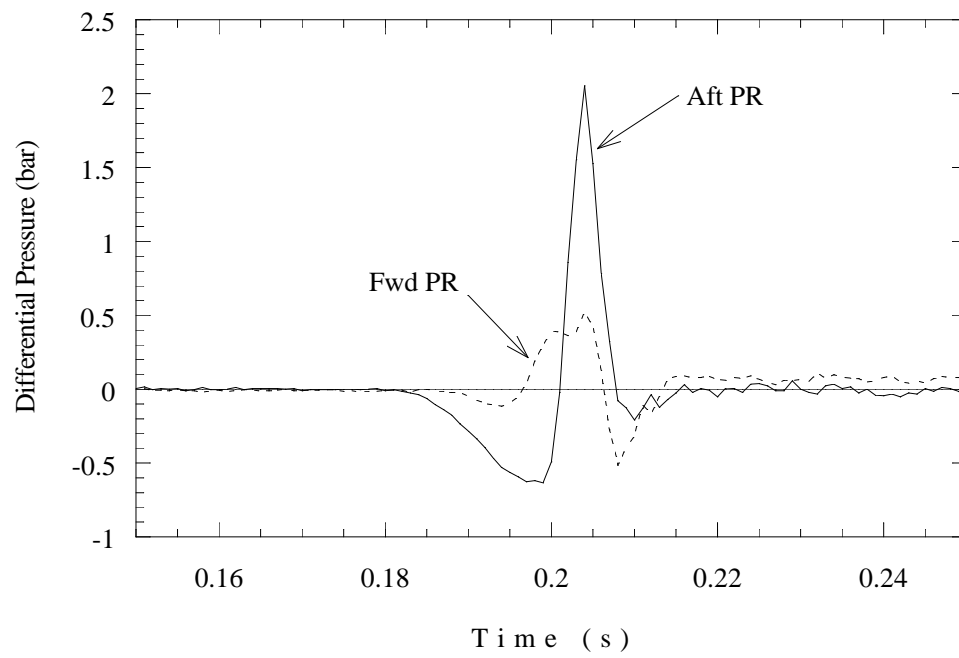
Figure 5.59: Differential pressure across PRs, ignition in bay 1. Test 7.

Figure 5.59 shows the large pressure differential that caused the failure of the aft PR. Failure presumably occurred when the pressure reached 2.1 bar and rapidly dropped. This plot also shows the non-symmetrical behavior of this test compared to ignition in bay 2.

After these flames enter bay 1, the turbulent flow generated by combustion in the other bays sweeps through bay 1 and brings combustion to completion. It is difficult to tell what causes partial failure of the aft PR. Possibly, the flame is initiated in bay 6 by the vent stringers, generating even more turbulence in bay 5. Once bay 5 ignites, it outpaces bay 6, creating the differential pressure which breaks the front end of the aft PR free and swings it starboard.

**Ignition in Bay 1 (Test 7)** It should be noted that the aft PR underwent partial failure in this test, and this should be considered in analysis of the results. “Partial failure” means that the PR did not completely break free from its mounts. In this test, the forward end of the aft PR broke free of its bracket and bent during the burn. Polycarbonate allows a great deal of deformation before fracture and the PR returned to its original position after the pressure difference dropped. The aluminum brackets were responsible for the failure; the edges of the holes pulled around the 5/16-in bolts holding the brackets to SWB1. The bending motion damaged the side of the brackets attached to the PR, but they held. The bracket on RS was replaced with a heavier one after this test; this change eliminated this type of failure.

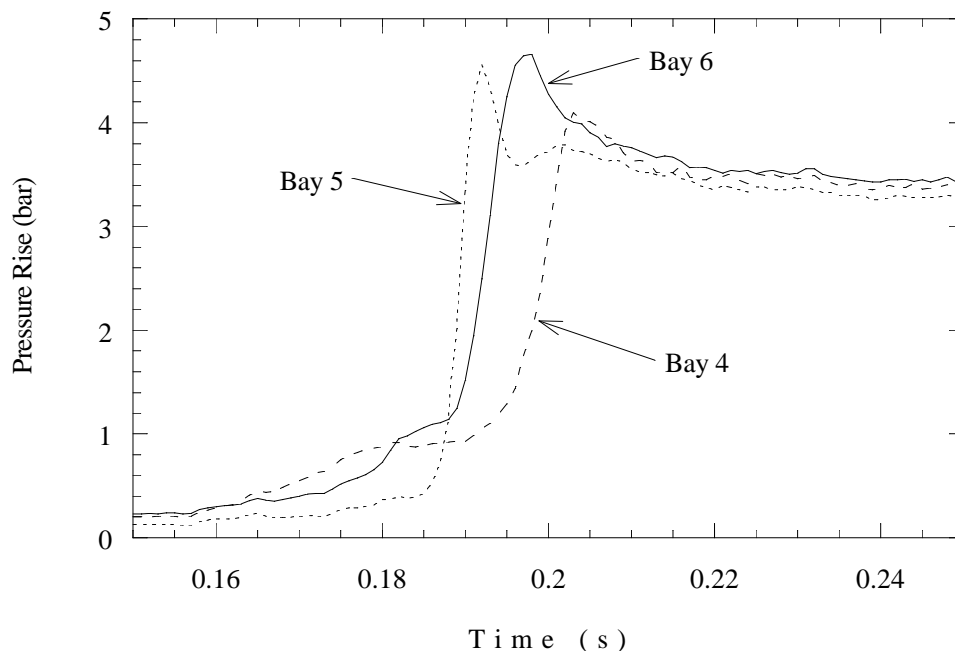
Figure 5.60: Pressure traces for bays 4, 5, 6, ignition in bay 6R. Test 15.

**Ignition in Bay 6R (Test 15)** The 6R ignition location is in bay 6, attached to the surface of SWB1 at a location 3 in from the starboard side and 2 in down from the top of the tank. This simulates a fuel probe location in the actual CWT. In this test, the forward PR failed at one end, and the aft PR failed completely by a combination of bolt failure and material fracture. Because of the failure of the partial rib, the geometry changed during the combustion event. This means that this test is not very useful for comparison with other tests or for numerical simulation unless the structural failure is also considered.

In addition to the PR failures, it also appeared that the outer edges of SWB1 swung forward and snapped back. The additional forces placed on the PRs by motion of SWB1 probably contributed to their failure. Some of the damage was quite extensive. The aft PR was actually fractured, whereas the aluminum bracket had failed in earlier tests. Some of the 10-32 screws were broken, too. Scuff marks in the rust on the top and bottom of the tank indicated that the edges of SWB1 and SWB2 deflected forward 0.75 to 1 in and returned. These marks could be from Test 14, but it looked like the buckling kinks in the SWB2 angle bracket were larger than they were before the test.

The pressure traces from bay 6 and the adjacent bays 4 and 5 are shown in Fig. 5.60. The flame enters bay 4 shortly after ignition because of the corner and vent stringer passages located near the ignitor. Thus, both bays undergo slow combustion at first, although there is some communication between them. Bay 5 shows a slow pressure rise from the combustion in 4 and 6, until it ignites at 185 ms and burns rapidly. Figure 5.61 adds the pressure trace from bay 3, which follows the early pressurization of bay 5 and ignites shortly after bay 5. Bay 3 experiences the highest pressure peak.

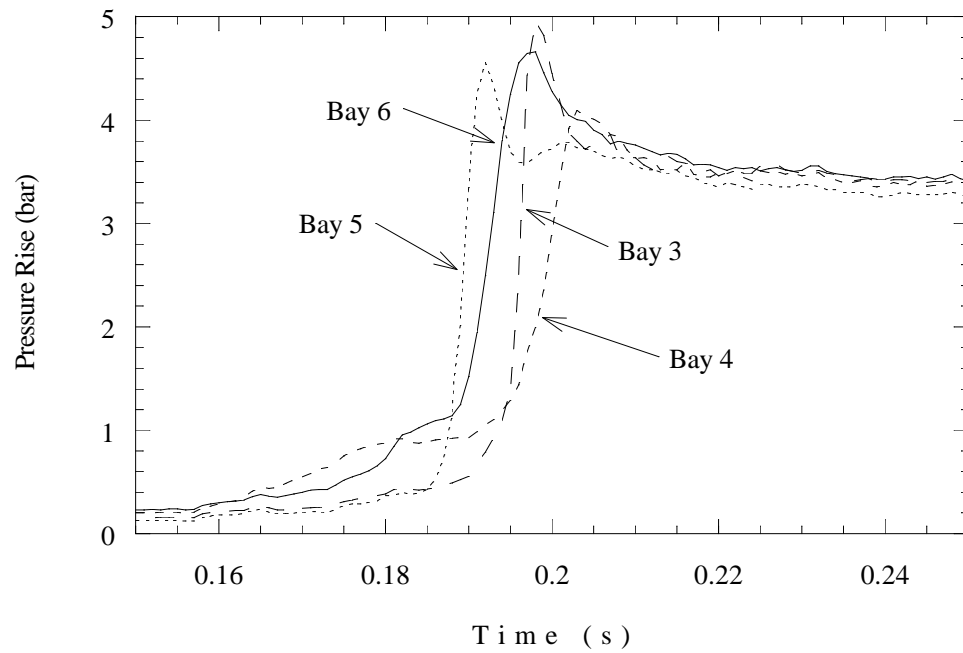
Figure 5.61: Pressure traces for bays 3 – 6, ignition in bay 6R. Test 15.

The pressure traces from bays 1 and 2 are shown in Fig. 5.62, with bays 4 and 6 for reference. In Fig. 5.61, we observe a slow initial pressure rise in bays 3 and 5 with pressures lower than in bays 6 and 4 until about 185 ms. This indicates that bays 3 and 5 were probably not ignited prior to that time, and were only being pressurized by outflow from bays 6 and 4. On the other hand, the early-time pressure in bays 1 and 2 closely follows the pressure in bay 6 until about 180 ms. Data from the thermocouples (Table 5.19) show that the flame runs up the starboard side of the tank very rapidly. Therefore we conclude that combustion begins in bays 2 and 1 shortly after the ignition in bay 6. The combustion is relatively slow and the peak pressures in bays 2 and 1 do not occur until about 230 ms, compared to 195 to 200 ms for the other bays.

As stated above, both PRs suffered damage in this test. In Fig. 5.65, it appears that the forward PR failed at the peak pressure of 3 bar, although it remained attached at one end. The aft PR completely failed and was blown to the starboard, although the pressure differential shows a negative phase. This appears to last too long to be caused by flow from bay 5 after rupture of the PR, so perhaps the PR continued to divide the bays for a short time after it separated from the brackets. This would put the failure of the PRs at just before 200 ms.

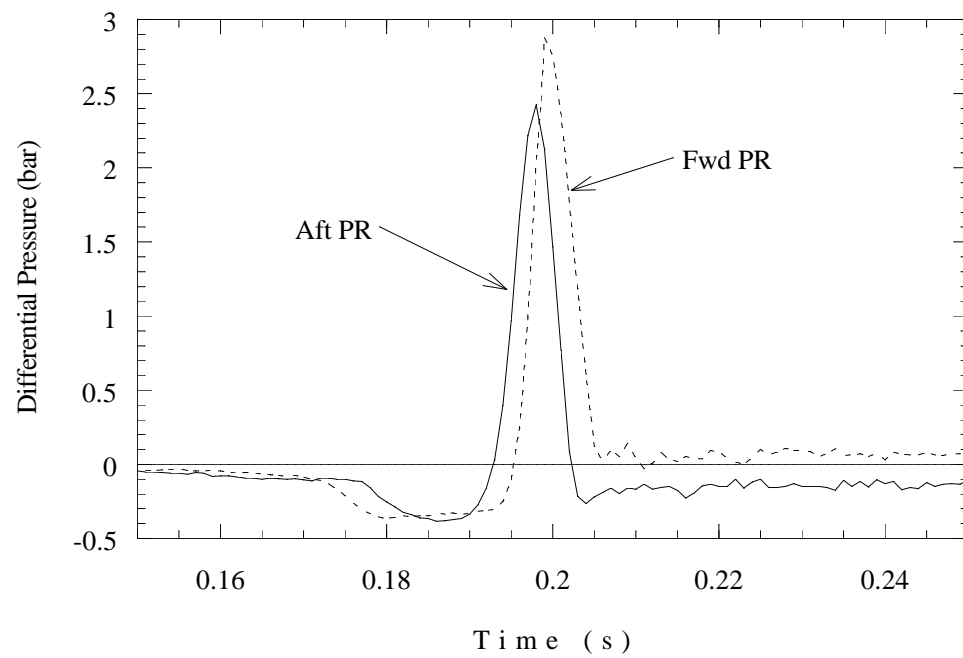
Figure 5.72: Differential pressure across PRs, ignition in bay 1R. Test 16.

Finally, Fig. 5.72 shows the lack of symmetry in the flame propagation via the pressure differentials across the partial ribs. The negative phase indicates combustion in the starboard side of the tank. The mixture in bays 3 and 5 become highly turbulent due to jetting from bays 4 and 6. When bays 3 and 5 are ignited, the pressure increases rapidly. The PRs probably failed near the peak pressure point. It is unknown why the aft PR trace shows a residual pressure difference after the main combustion event is over. The aft PR failed completely.

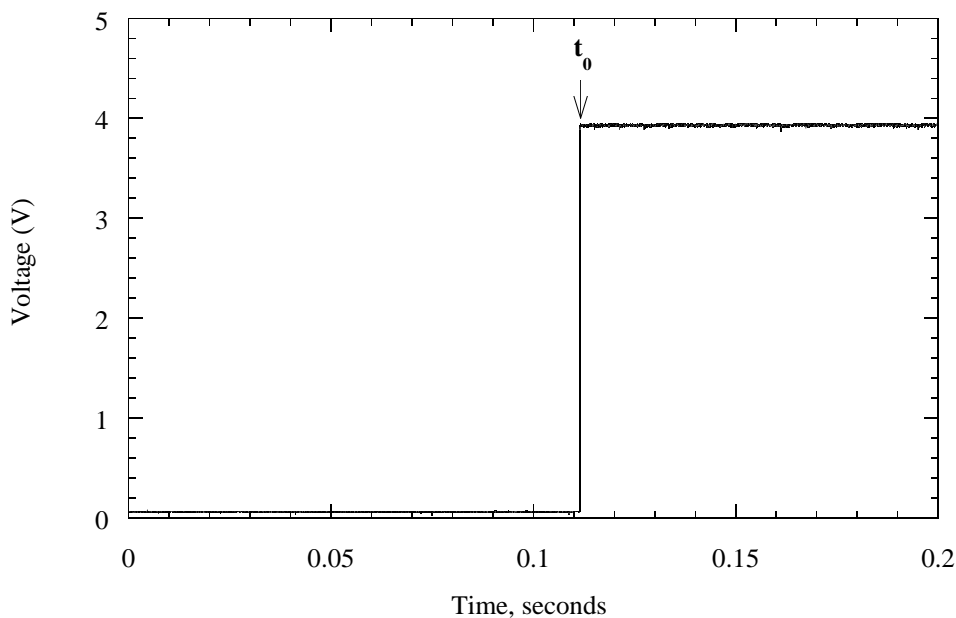
When weak partitions are used in a test, motion detectors or break switches are installed to record failure times, providing a non-ambiguous time of initial panel motion, as shown in Fig. 5.80. This signal was recorded from motion switch 8 during Test 19.

Figure 5.80: Typical motion detector signal showing the sharp transition to a higher voltage at the moment it is triggered ( $t_0$ ).

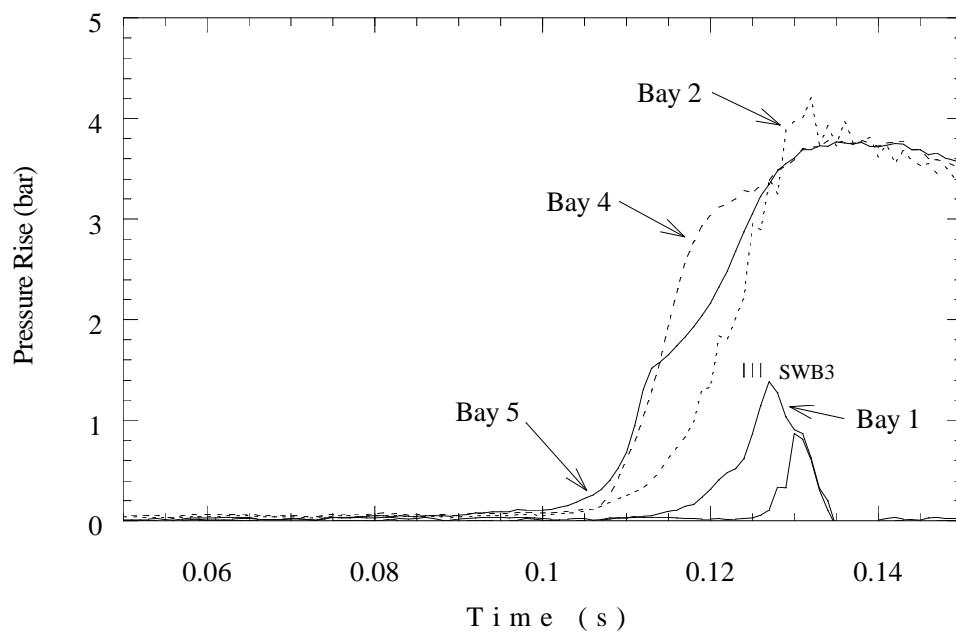
Figure 5.83: Pressure traces from bays 5, 4, 2, 1, with breakage indicators from SWB3. The trace under that for bay 1 is from bay 0, though no FS was used in this test. Test 13.

Bay 1 peaks at about 1.4 bar. The motion detector signals indicate that the panel begins to break at less than 0.8 bar, but the combustion continues to drive the pressure up in the time it takes the panel to fail completely. The pressure from bay 0 is shown also, falling under that for bay 1. It is shown here only for reference, as the FS was not installed. The panel appears to fail uniformly.

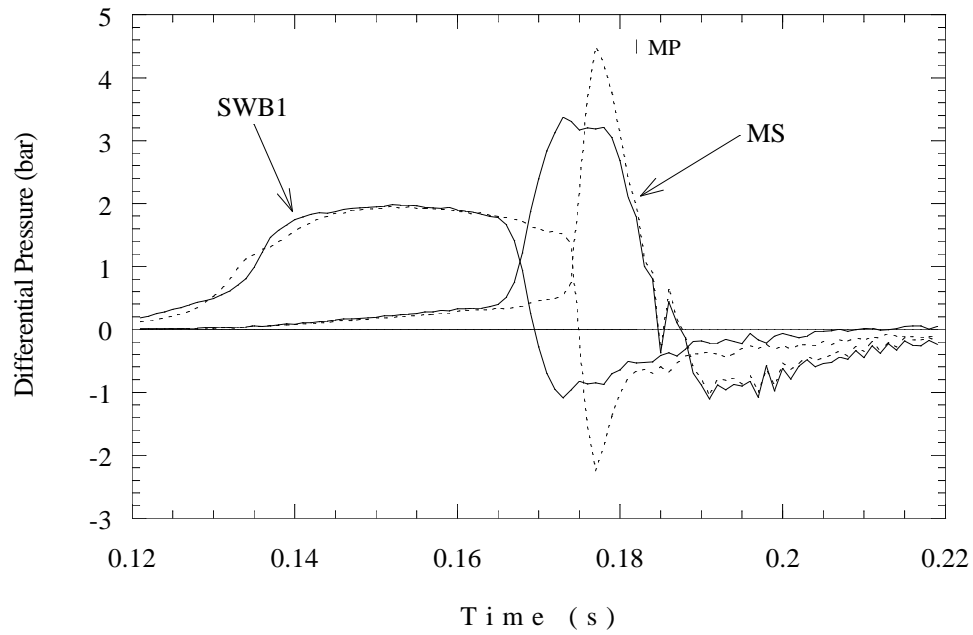
Differential pressures across SWB1 and MS are shown in Fig. 5.90. These are easily reconciled with the pressure traces. The rapid reversal of the differential pressure in bay 5 at 165 ms and bay 6 at 170 ms coincides with the ignition of bay 4, then bay 3.

Figure 5.90: Differential pressure across SWB1 and MS, weak MP, ignition in bay 5. Dashed lines indicate port side of partition, solid lines indicate starboard. Test 14.

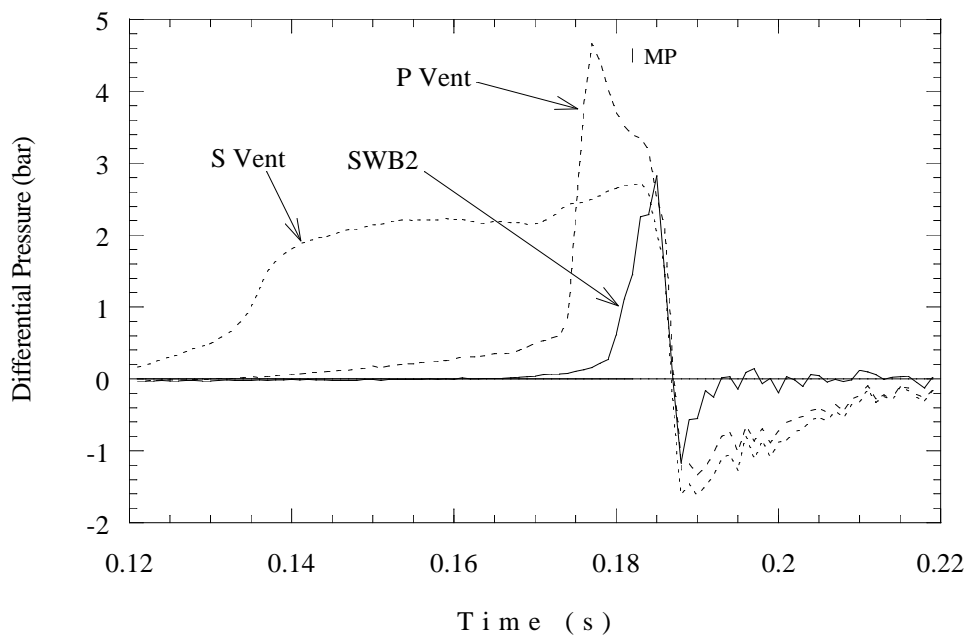
The SWB2 differential pressure (Fig. 5.91) slowly rises as gas from the aft bays vents into bay 2, and then rapidly increases when the flame reaches bay 2. When the MP breaks, there is a sharp drop. The vent pressure differentials reflect the combustion sequence in the aft bays. The starboard vent differential pressure increases first while bay 6 burns. The port vent differential

Figure 5.91: Differential pressure across SWB2 and vents, weak MP, ignition in bay 5. Test 14.

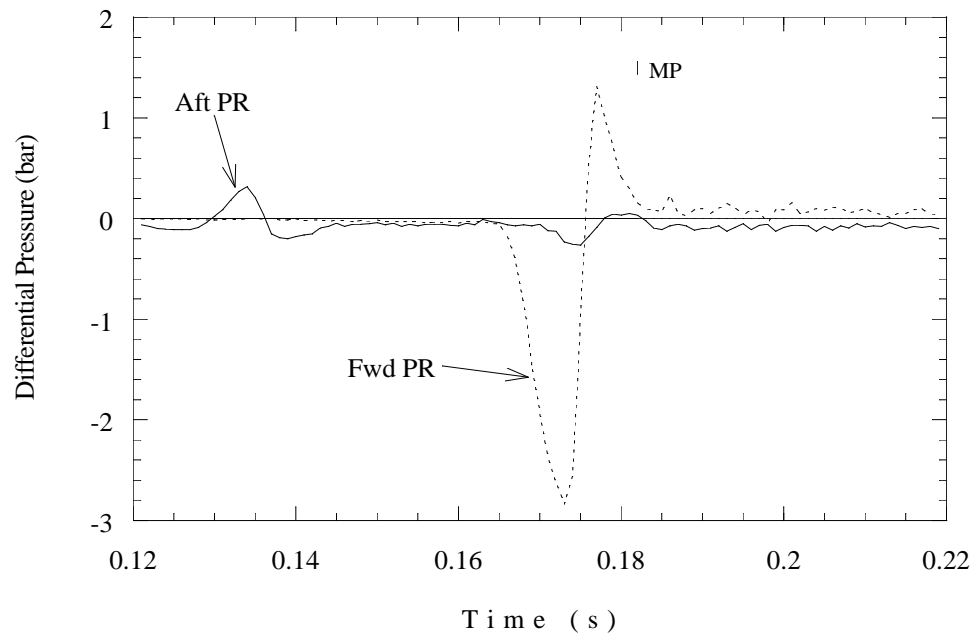
The aft PR, in Fig. 5.92, shows very little pressure differential. The aft partial rib has the largest flow area ( $6.8 \text{ in}^2$ ) of any partition except when the MP in SWB2 is ruptured. Flow through the passageway serves to equalize the pressure quickly between bays 5 and 6; in addition rapid lateral flame motion results in nearly simultaneous combustion between bays 5 and 6. The flow area in the forward PR is smaller ( $2.8 \text{ in}^2$ ) than in the aft PR and there are usually large differences in ignition time of bays 3 and 4. This results in much larger pressure differentials across the forward partial rib than the aft.

Figure 5.92: Differential pressures across PRs, weak MP, ignition in bay 5. Test 14.

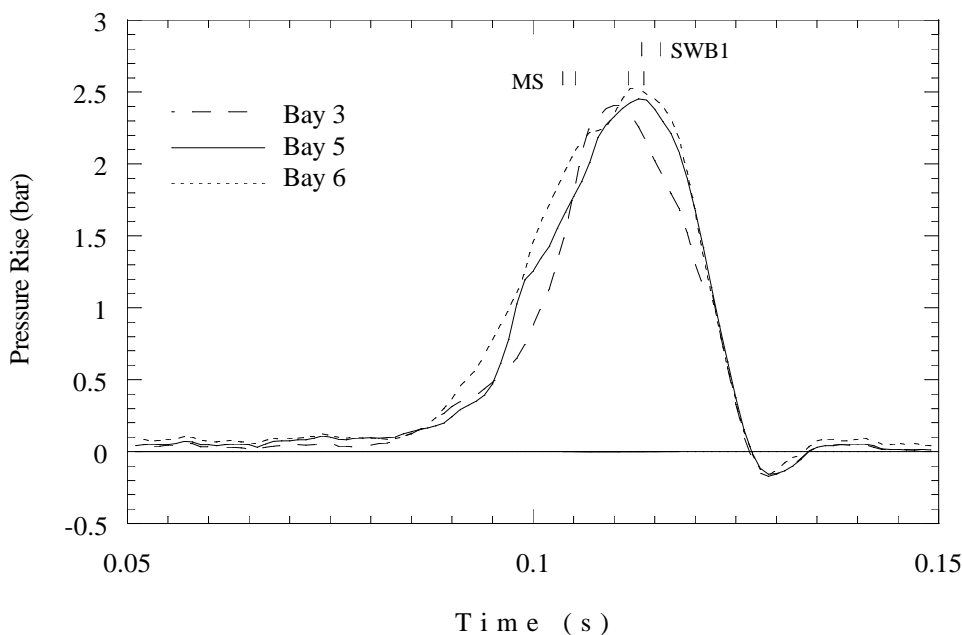
The pressure traces are shown in Figs. 5.93 – 5.100. In Fig. 5.93, we see behavior typical of bay 5 ignition in the all-strong tests, except that the pressures now peak at about 2.5 bar rather than 4 bar. Note that the MS begins to fail earlier and complete failure takes 10 ms, as compared to 2 ms for SWB1 (Table 5.42). The pressure drop in bay 4 (Fig. 5.94) corresponds to the MS failing first on the starboard side.

Figure 5.93: Pressure traces for bays 5, 3, 6, ignition in bay 5, all weak partitions. Markers indicate tripping of motion detectors. Test 18.

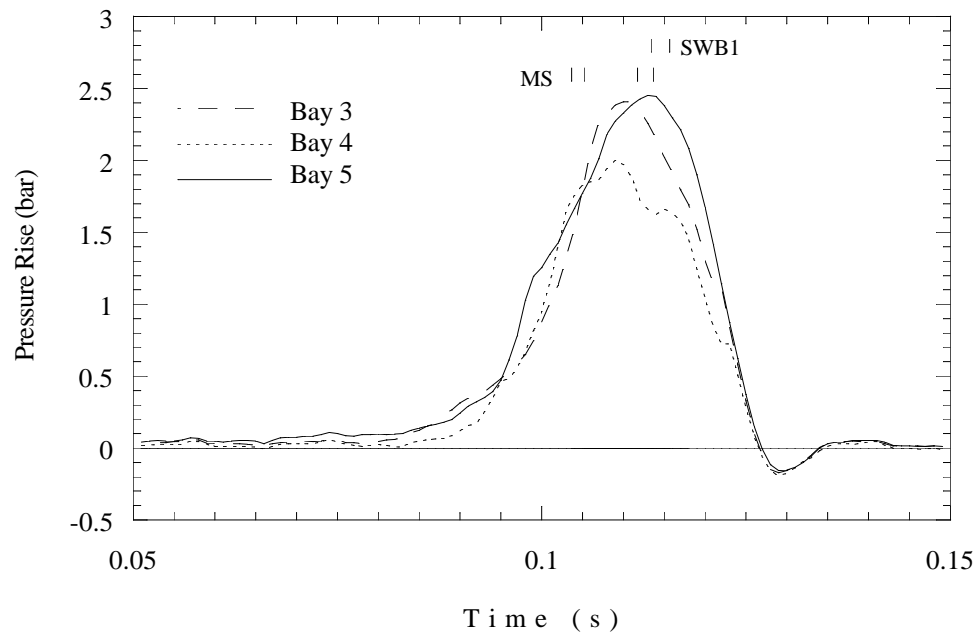
Figure 5.94: Pressure traces for bays 5, 3, 4, ignition in bay 5. Test 18.

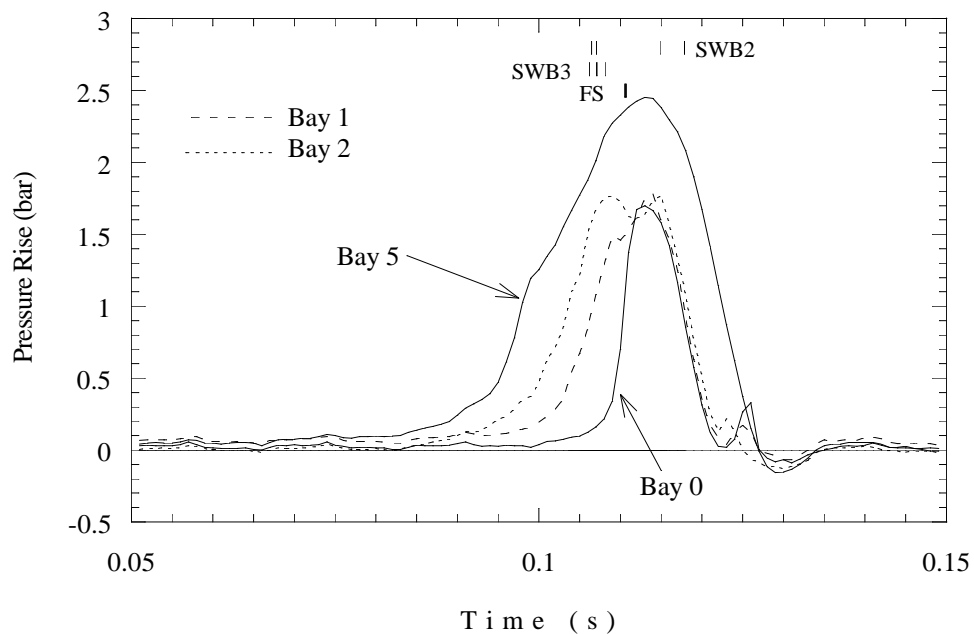
Figure 5.95 shows the pressures from the forward bays. Combustion appears to progress sequentially from back to front. Bay 0 contains no combustible mixture, so it does not show

a pressure signal until the rupture of SWB3, which occurs over a short period of time after 105 ms. The inertia of the gas and the pressurization of bays 0, 1, and 2 provide a confining action that enables higher peak pressures in the aft bays than in the forward bays. The negative phase at 130 ms is associated with the overexpansion caused by the gas motion emptying the tank after all the partitions have exited.

Figure 5.95: Pressure traces for bays 1, 2, 5, 0, ignition in bay 5. Test 18.

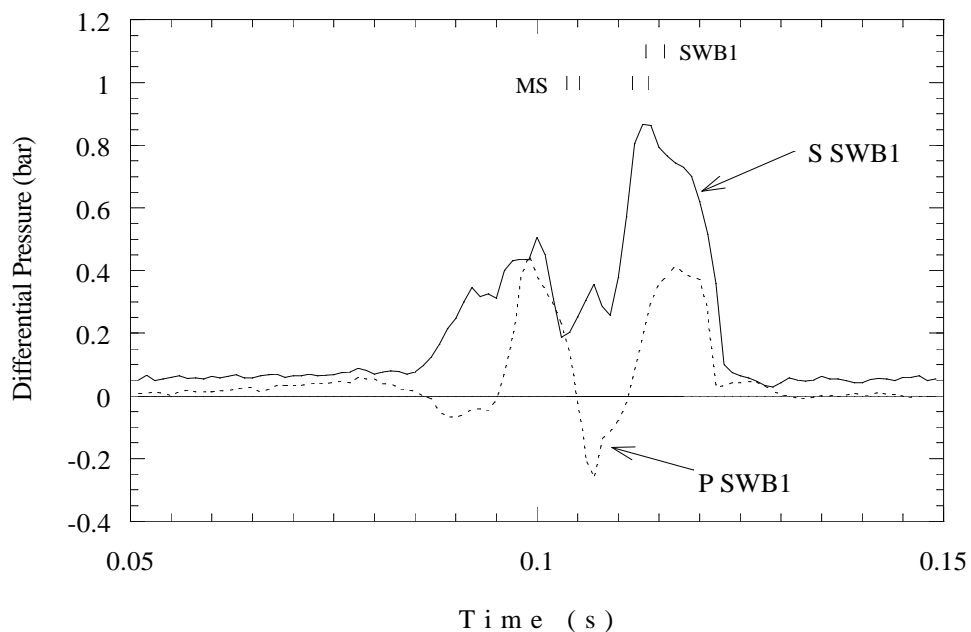
Differential pressures are shown in Figs. 5.96 – 5.100. Figure 5.96 shows SWB1 failing when the pressure difference reaches about 0.9 bar on the starboard side. This is somewhat lower than the nominal failure pressure of 1.36 bar. The MS begins to fail (0.8 bar differential pressure) on the starboard side at about 10 ms before SWB1 begins to fail. The port side of the MS fails next (1.0 bar differential pressure), but the differential pressure peaks later at about 120 ms.

Figure 5.96: Differential pressures across SWB1. Test 18.

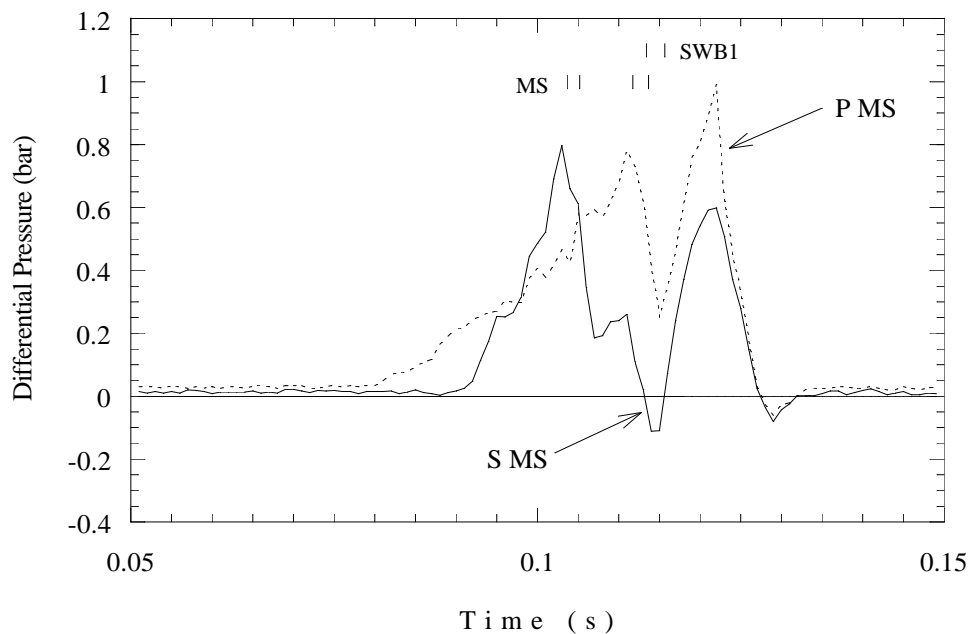
Figure 5.97: Differential pressure across MS. Test 18.

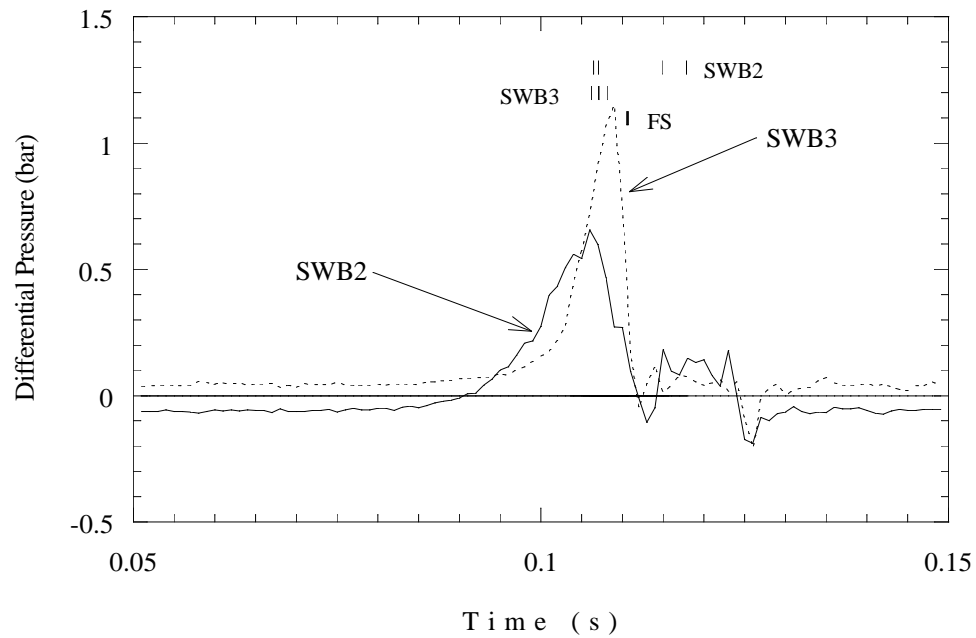
SWB2 begins to fail at a low (0.5 bar) differential pressure (Fig. 5.98), but SWB3 fails at 1.1 bar, closer to the desired differential pressure. The pressure drops rapidly after SWB3 fails, as it is the boundary to atmosphere. SWB3 fails over a much shorter time span than the aft partitions.

Figure 5.98: Differential pressure across SWB2 and SWB3. Test 18.

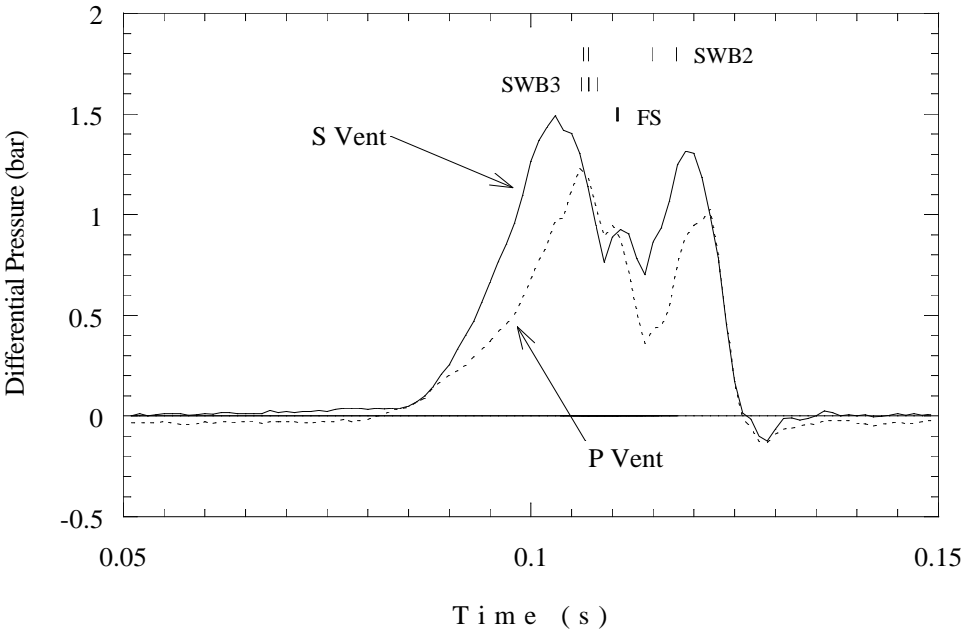
Differential pressures across the vents are shown in Fig. 5.99. The pressure differential across the FS is simply the bay 0 pressure given in Fig. 5.95. The FS fails at nearly all corners simultaneously. Witness marks on SWB3 indicate that SWB3 typically impacts the FS and wraps itself (and FS) around the water bottles. The pressure rises sharply until FS fails, at which point the pressure makes a more gradual drop. The late spike in the trace for the FS is interesting. It may be a result of the late failure of the aft partitions. The vents are able to build up pressure, as the aft partitions fail later. The reason for the second peak at 120 ms is unclear; SWB3 has failed 5 ms earlier, so it is not due to the sudden drop in bay 0 pressure.

Figure 5.99: Differential pressure across vents. Test 18.

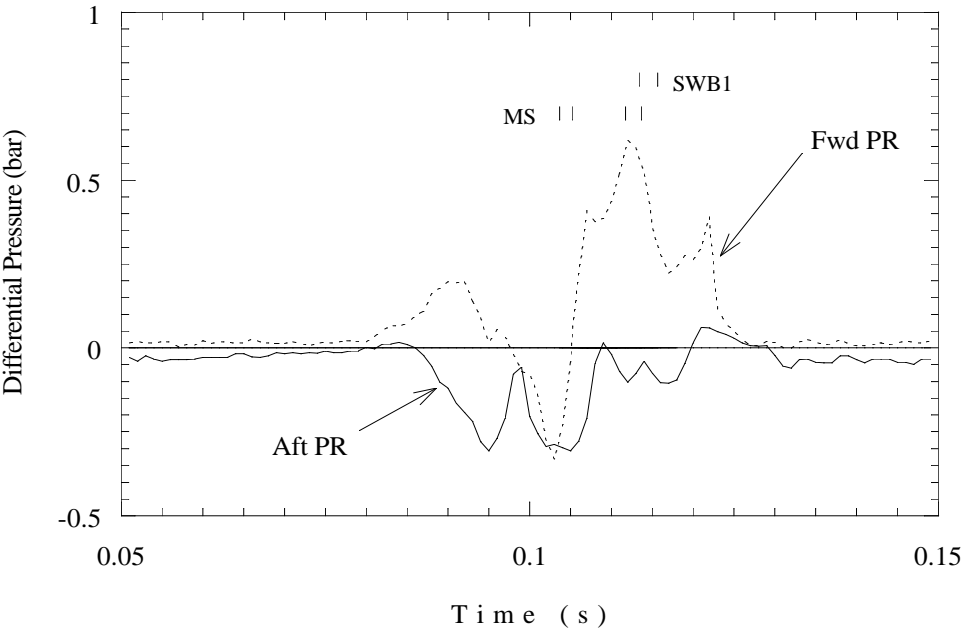
Differential pressures across the PRs are not very large, as the partitions fail before large pressures can build. The forward PR shows a positive pressure differential at 110 ms, which is consistent with the starboard side of MS failing and venting that compartment before the port side.

Figure 5.100: Differential pressure across PRs. Test 18.

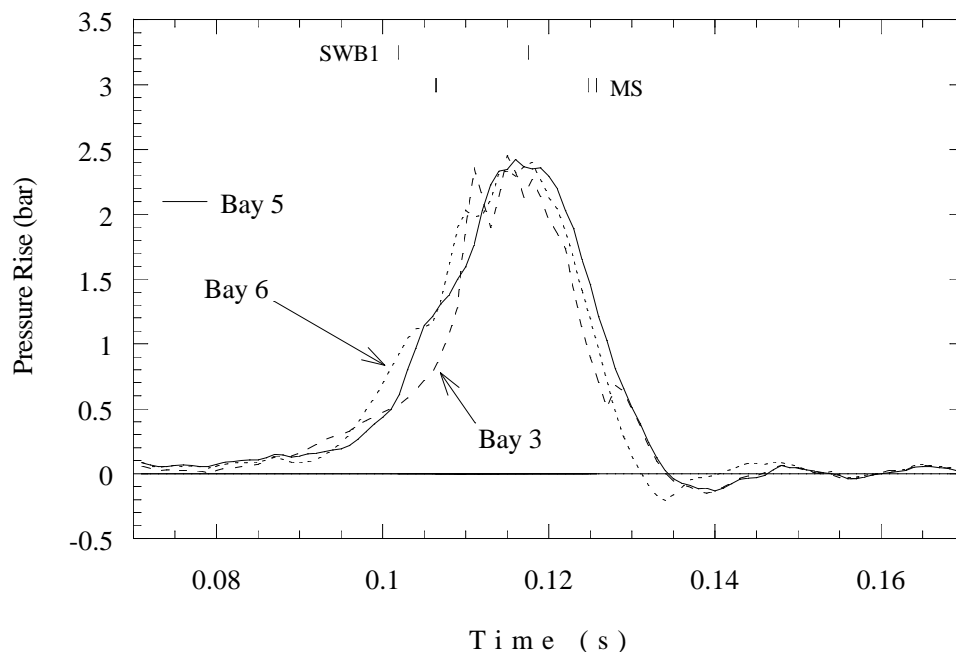
Pressure traces are shown in Figs. 5.101 – 5.109. Note from the figures and Table 5.28 that the port sides of SWB1 and MS fail much later (20 ms for MS) than the starboard sides. In Fig. 5.101, we see the pressure traces for bay 5 and the adjacent bays, 3 and 6. Some of the typical interplay between bays 5 and 6 occurs, but partition failure begins before this can progress further. Figure 5.102 replaces the trace of bay 5 with that of bay 4, and we see that bay 4 still undergoes late ignition and rapid pressure rise, but this is cut short by failure of the port side of MS. Port side failure of SWB1 brings the traces of bays 4 and 6 together to some degree (note corresponding change in slope of bay 6 trace), but slight differences still occur until MS and SWB1 fail completely.

Figure 5.101: Pressure traces from bays 3, 5, 6, ignition in bay 5, with a cold liquid Jet A layer. Test 19.

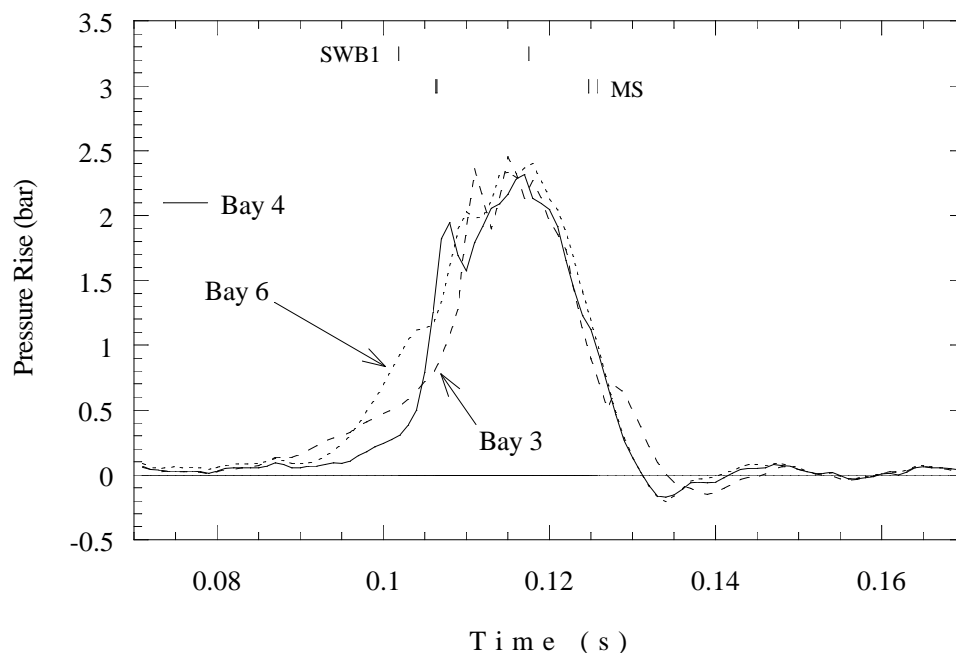
Figure 5.102: Pressure traces from bays 3, 4, 6, ignition in bay 5, with a cold liquid Jet A layer. Test 19.

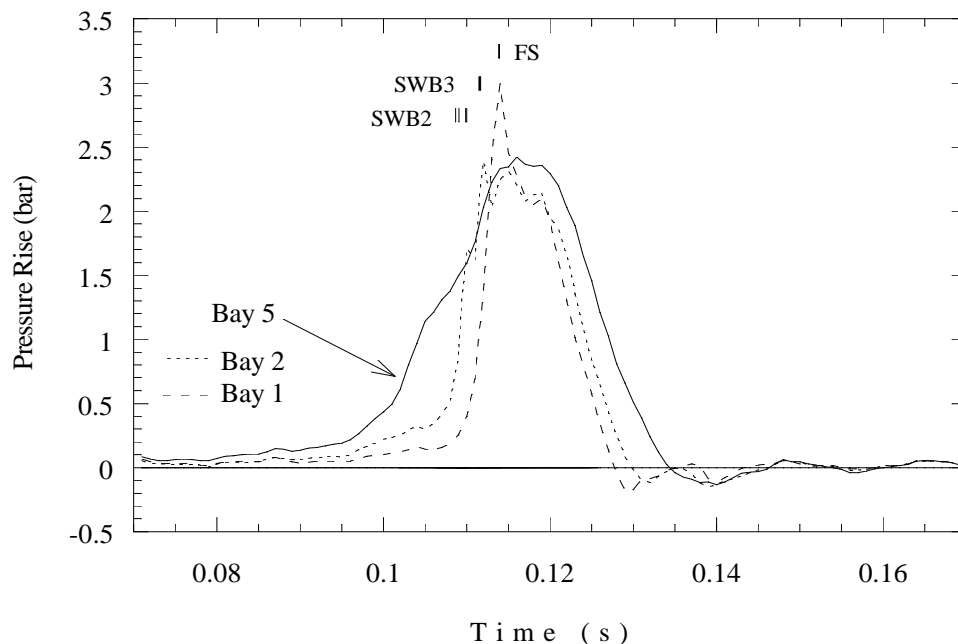
Figure 5.103 shows the pressure in bays 1 and 2 with bay 5 for reference. Bays 2 and 1 ignite in sequence, and show an abrupt change in slope at about 110 ms. SWB3 fails when the bay 1 pressure is around 1 bar, but FS holds on for a short time longer, allowing the rapid pressure rise to peak at 3 bar. Bay 1 pressure drops immediately on the failure of FS, but halts at a brief plateau before continuing to zero. Bays 2 and 5 depressurize in sequence, as gas is

Figure 5.103: Pressure traces from bays 1, 2, 5, ignition in bay 5, with a cold liquid Jet A layer. Test 19.

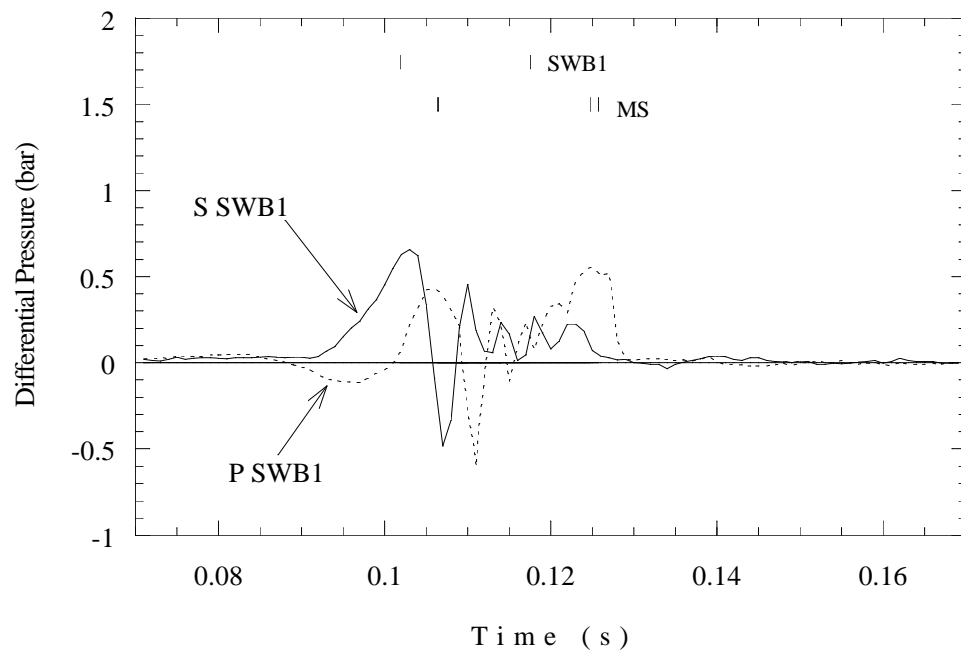
Differential pressures across SWB1 and MS are shown in Figs. 5.105 and 5.106. The starboard side of SWB1 appears to fail with a differential pressure of less than one bar; the port side shows no large differentials when its failure is sensed. However, bottom sensors were not used on SWB1, so it is possible that the bottom of the partition failed earlier, reducing the pressure differentials, and later taking the top portion with it. The port side of MS also shows no large peaks directly associated with its failure, and both top and bottom were recorded. A 0.55-bar peak occurs shortly after indicated failure, so the motion detectors may have melted before they were actually tripped. The starboard side of MS, in contrast, shows a sharp peak of nearly 1.5 bar when failure occurs.

Figure 5.105: Differential pressure across SWB1, ignition in bay 5, with a cold liquid Jet A layer. Test 19.

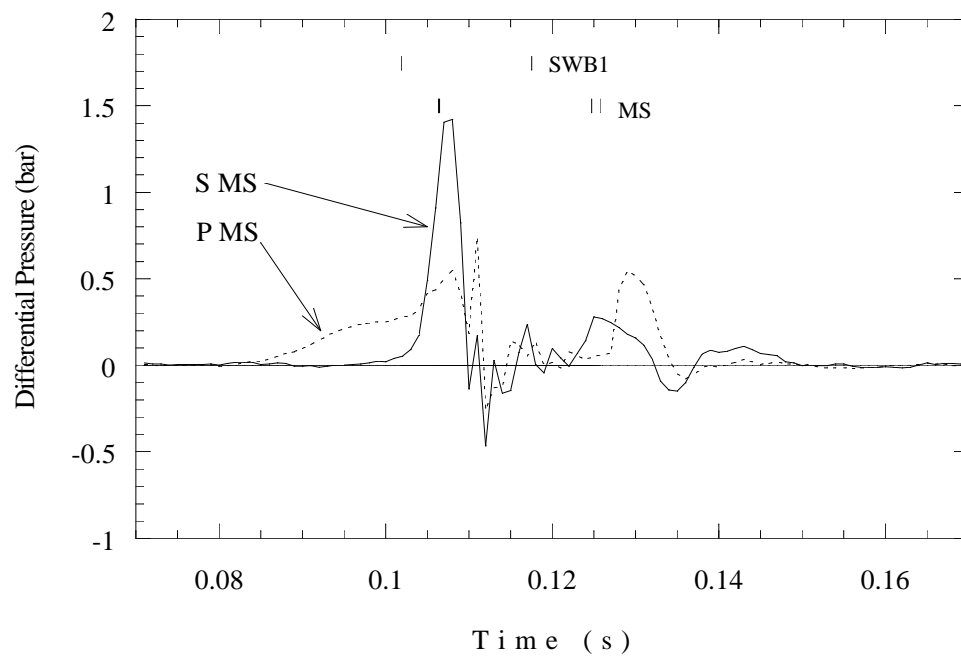
Figure 5.106: Differential pressure across MS, ignition in bay 5, with a cold liquid Jet A layer. Test 19.

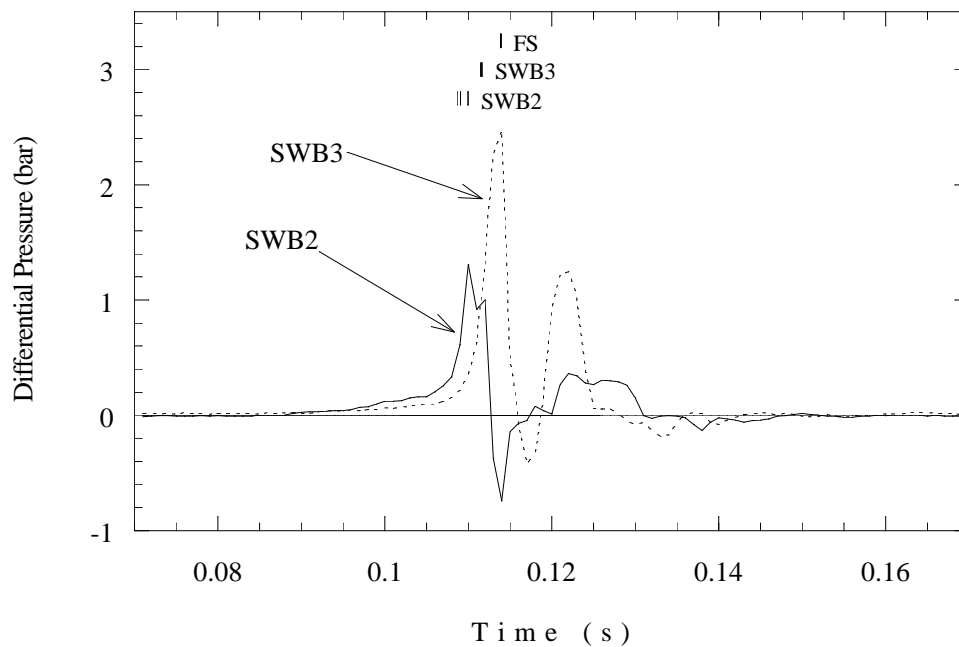
The failures of SWB2 and SWB3 are also clear, as shown in Fig. 5.107. SWB2 fails with a peak of 1.3 bar, and its failure generates a large amount of turbulence, as well as possible fuel lofting, yielding a very rapid pressure rise in bay 1 and a corresponding high failure pressure of 2.5 bar on SWB3. The late peak in differential pressure on SWB3 is probably due to the late failure of the port MS, but it is unclear why this would show up as a differential and not a static pressure. This may be caused by the passage of the aft partitions, which will retain some pressure behind them as they are ejected from the tank.

Figure 5.107: Differential pressure across SWB2 and SWB3, ignition in bay 5, with a cold liquid Jet A layer. Test 19.

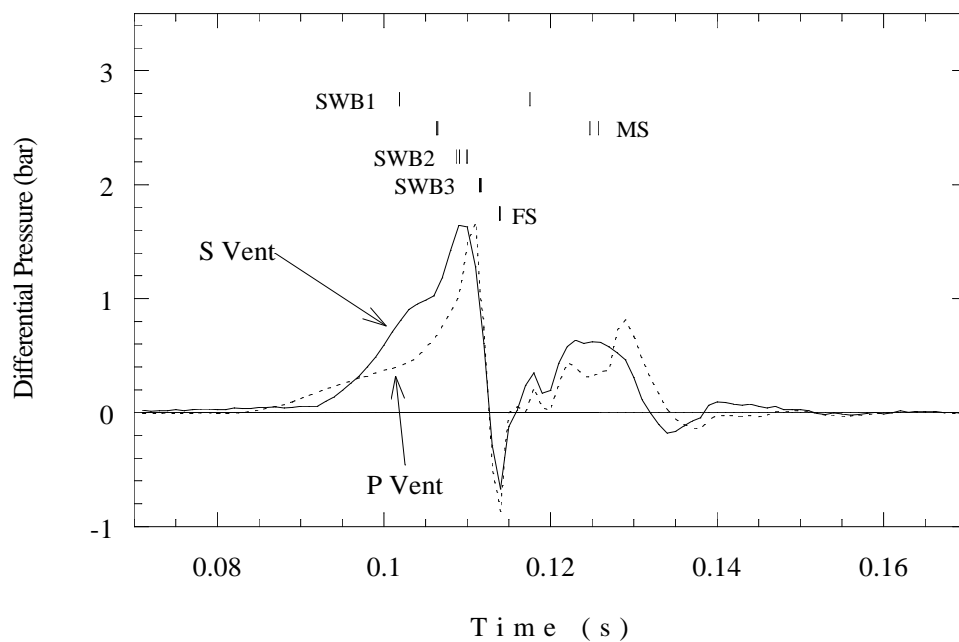
Figure 5.108 shows the similar patterns of behavior of the two vent stringers, and with all failure marks present, shows the aft-forward failure sequence. The MS and SWB1 both take

Figure 5.108: Differential pressure across vents, ignition in bay 5, with a cold liquid Jet A layer. Test 19.

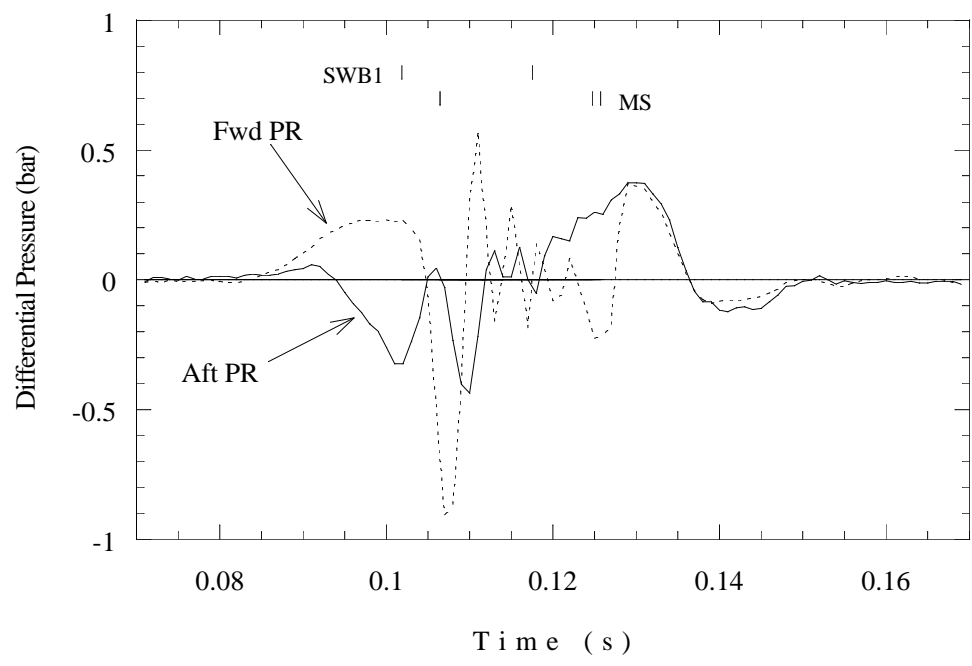
a long time to fail on the port side and the second peak in differential pressure at 125 ms is attributable to the late failure of the MS. The PRs show small but sharply fluctuating pressure differentials over the course of the failure process. Pressure across the forward PR initially reflects the rapid combustion in bay 3, but failure of the starboard side of SWB1 generates turbulence in bay 4, accelerating combustion there and producing a rapid drop and negative differential pressure on the forward PR. By the time total failure has occurred in the aft bays, the differentials equilibrate. The PRs may have stayed intact, connecting SWB1 and MS, even after the partitions failed. This would account for the finite and equal pressure differential on both forward and aft PRs after 130 ms.

Figure 5.109: Differential pressure across PRs, ignition in bay 5, with a cold liquid Jet A layer. Test 19.
