**Results of 1/4-Scale Experiments.**  
**Vapor Simulant And Liquid Jet A Tests**

17 July 1998 **Revised January 28, 2000**  
Explosion Dynamics Laboratory Report FM98-6

*Prepared for and supported by the National Transportation Safety Board*

The National Transportation Safety Board (NTSB) sponsored a testing program associated with the investigation into the TWA Flight 800 accident which occurred in July of 1996. California Institute of Technology (Caltech) and Applied Research Associates, Inc. (ARA) worked together with the NTSB to perform a study of combustion within a 1/4-scale model of a 747-100 Center Wing Tank (CWT). Tests were performed with the model to examine various ignition locations, vapor concentrations, the effect of a liquid fuel layer, and the failure of the internal partitions that represented the beams and spars within the tank.

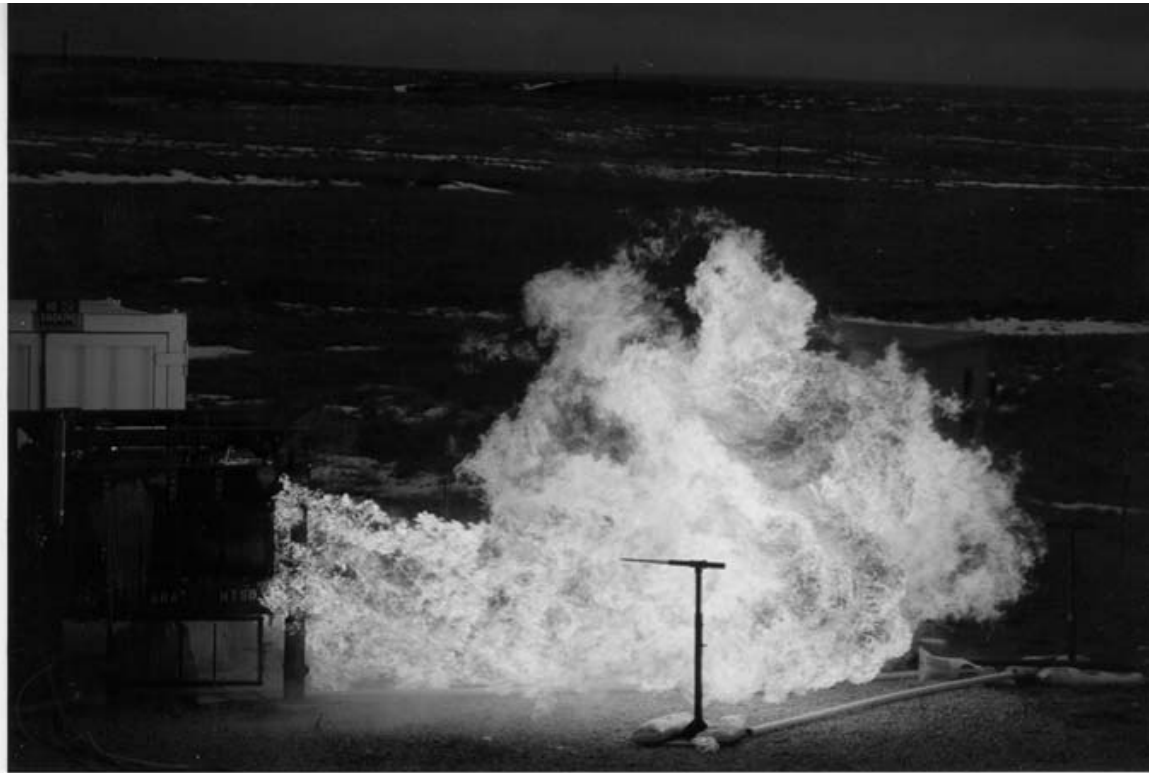
Fig. 5.110, and as a series of wide angle frames from the 8 fps Nikon in Fig. 5.111. The fireball engulfed the partitions as they were ejected, making it difficult to determine the grouping. One panel (SWB1) came out alone, after the others had apparently emerged together. This means that MS, SWB2 and SWB3 were all wrapped around the water bottles with FS. The blast gauge protector was torn from the ground and the weld to the reinforcing strut broken when the partitions impacted.

Figure 5.110: Fireball from Test 19 at approximately its greatest extent.

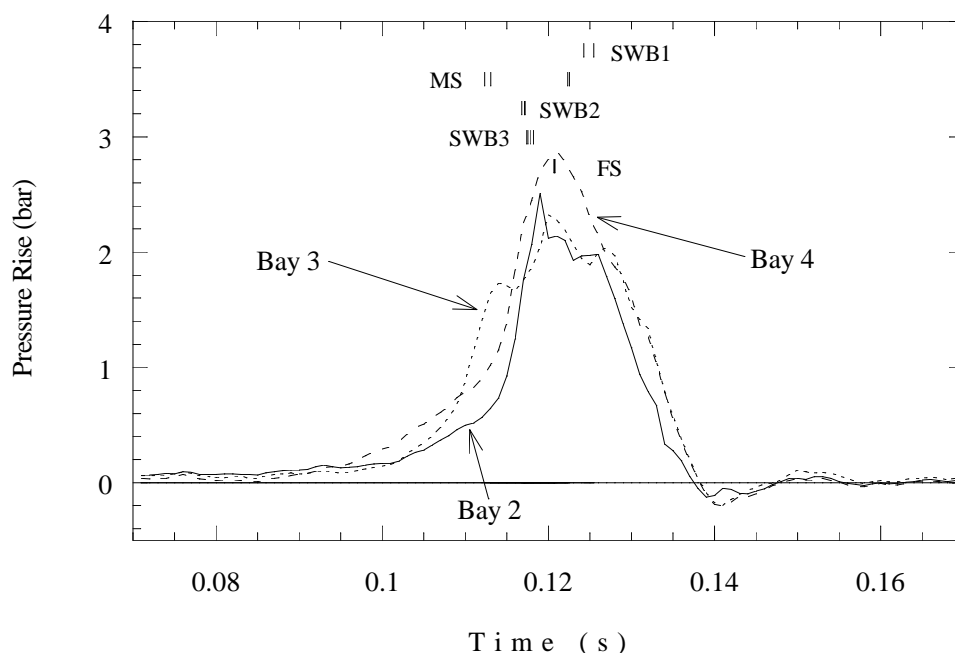
The associated pressure traces and partition failure signals are shown in Figs. 5.112 – 5.119. The proximity of the ignitor to passageways in the MS allows the flame to rapidly enter bays 3 and 4, as shown in Fig. 5.112. The video indicates that the flame enters bays 3 and 4 in a turbulent state, after some lofting has occurred. Venting of bays 3 and 4 into bay 2 generates turbulence, and accelerates the remainder of combustion, shown by the change in slope at 115 ms. It also appears that bay 3 ignites slightly before bay 4, possibly due to the lower MS passageway being located closer to the ignitor on that side of the tank. MS fails earlier on the port side than on the starboard, causing the pressure in bay 3 to dip slightly at 110 ms. Bay 4 remains intact for another 5 ms, resulting in a pressure peak of nearly 3 bar. Pressure in bay 2 increases until the failure of SWB2 and SWB3, and begins to drop after the FS fails.

Figure 5.112: Pressure traces from bays 2 – 4, ignition in bay 2Lo, with a cold liquid Jet A layer. Test 20.

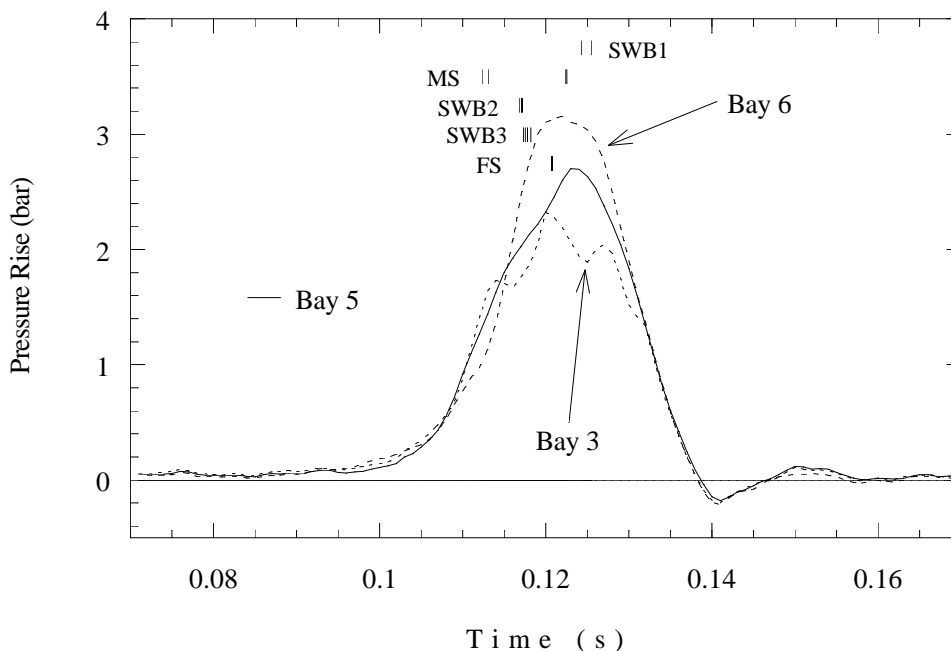
Bays 5 and 6 appear to ignite simultaneously with bay 3, as shown in Fig. 5.113. SWB1 was the last partition to fail in this test, resulting in higher peak pressures in the aft bays than in the forward bays. Bay 6 reaches the highest peak, with SWB1 probably supported on the starboard side by high pressure in bay 4. Both bays 5 and 6 vent rapidly after SWB1 fails.

Figure 5.113: Pressure traces from bays 3, 5, 6, ignition in bay 2Lo, with a cold liquid Jet A layer. Test 20.

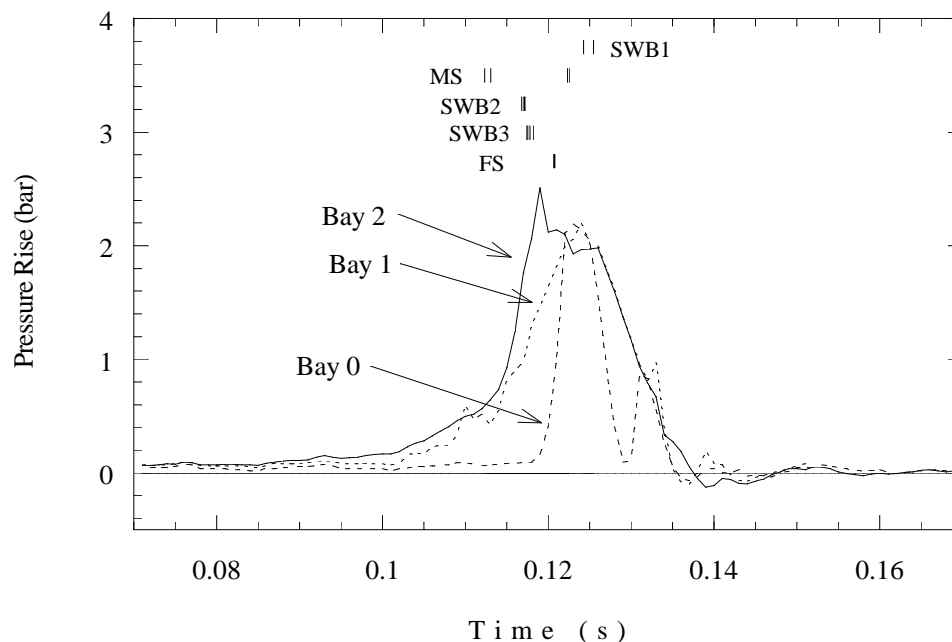
more slowly after SWB3 fails, but continues to increase due to the confinement by the FS. Failure of SWB3 causes pressurization of bay 0, which peaks and vents shortly after FS fails. Interestingly, bays 1 and 2 vent at a slower rate. There is also a late spike in the bay 0 pressure. This was probably caused by slow passage of one of the rear partitions. As mentioned above, SWB1 and MS were caught at the forward end of the tank and failed to exit completely. Once the panels reached the end of the tank, bay 0 vented at the same rate as bays 1 and 2.

Figure 5.114: Pressure traces from bays 0 – 2, ignition in bay 2Lo, with a cold liquid Jet A layer. Test 20.

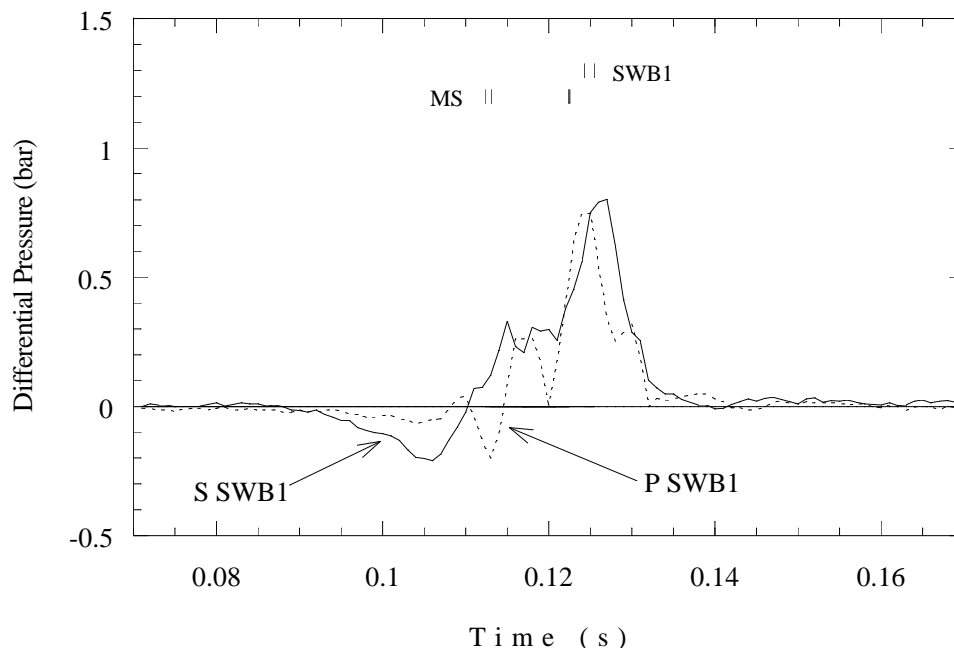
Differential pressures across SWB1 and MS are shown in Figs. 5.115 and 5.116, respectively. We see that SWB1 experiences only moderate loads, and doesn't fail until the differential pressure reaches about 0.8 bar on both sides. This is lower than expected, but the forward PR is probably also pulling on SWB1, as MS failure is complete several ms earlier than SWB1. The 0.8-bar pressure difference is probably created by the venting of the forward portions of the tank. The MS port side fails at about 113 ms (peak pressure of 1 bar), followed by failure of the starboard side at 0.8 bar occurring at 122 ms. The rapid decrease in pressure difference on the port side is due to acceleration of combustion in bay 2 by the port MS rupture. The panel was probably still separating the bays, allowing some pressure differential to be maintained.

Figure 5.115: Differential pressure across SWB1, ignition in bay 2Lo, with a cold liquid Jet A layer. Test 20.

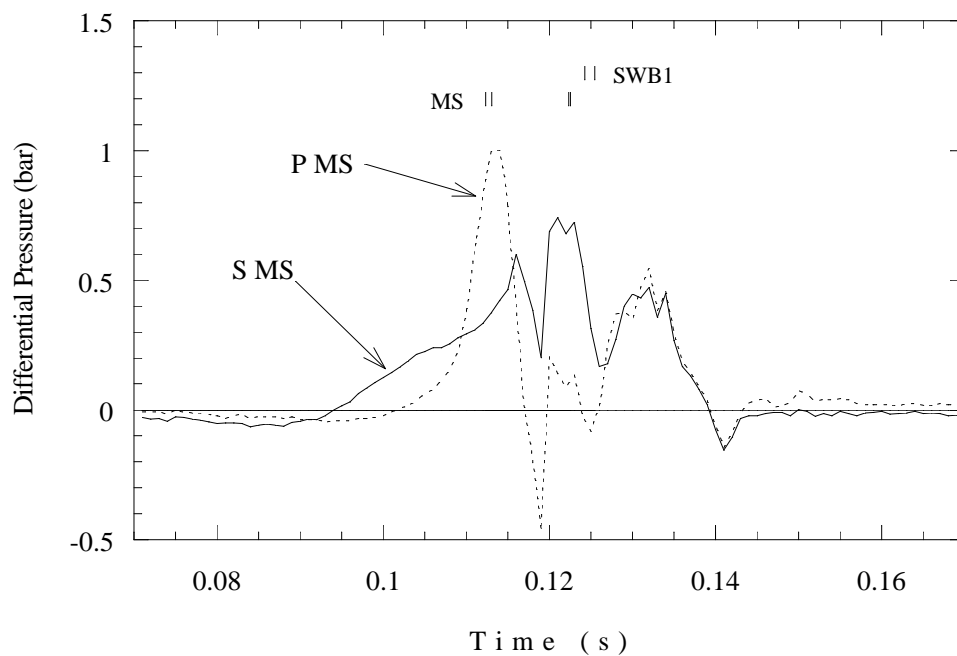
Figure 5.116: Differential pressure across MS, ignition in bay 2Lo, with a cold liquid Jet A layer. Test 20.

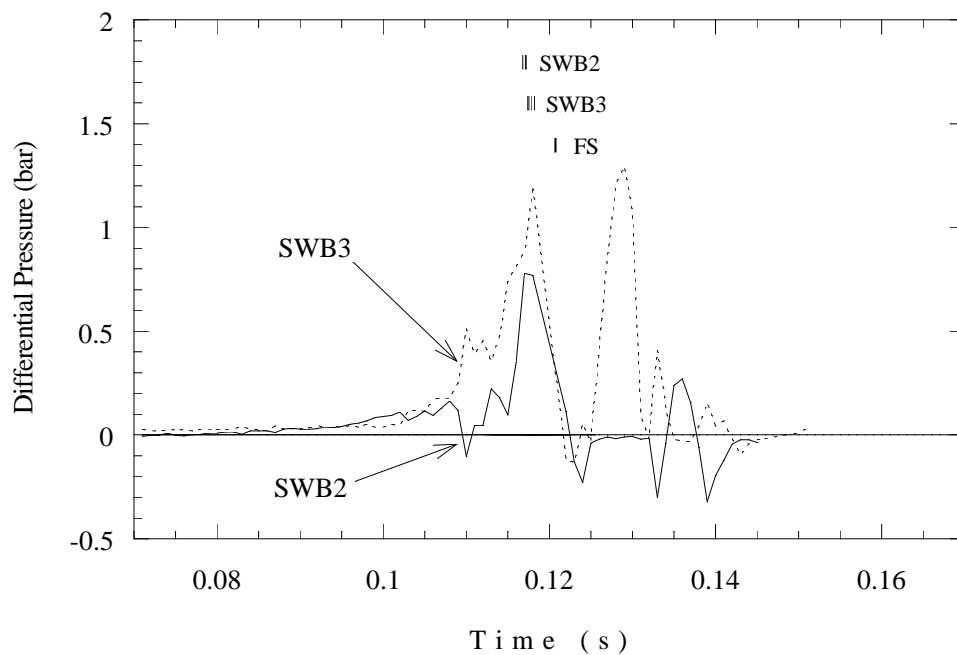
In Fig. 5.117, we see that SWB2 and SWB3 fail in rapid succession, almost simultaneously. The failures correspond to the peaks in the differential pressures observed at 117 ms. Note the second peak in SWB3 differential pressure at 129 ms. At the same time, the SWB2 pressure differential is zero, indicating that the SWB3 differential is associated with the passage of the aft partitions past this point.

Figure 5.117: Differential pressure across SWB2 and SWB3, ignition in bay 2Lo, with a cold liquid Jet A layer. Test 20.

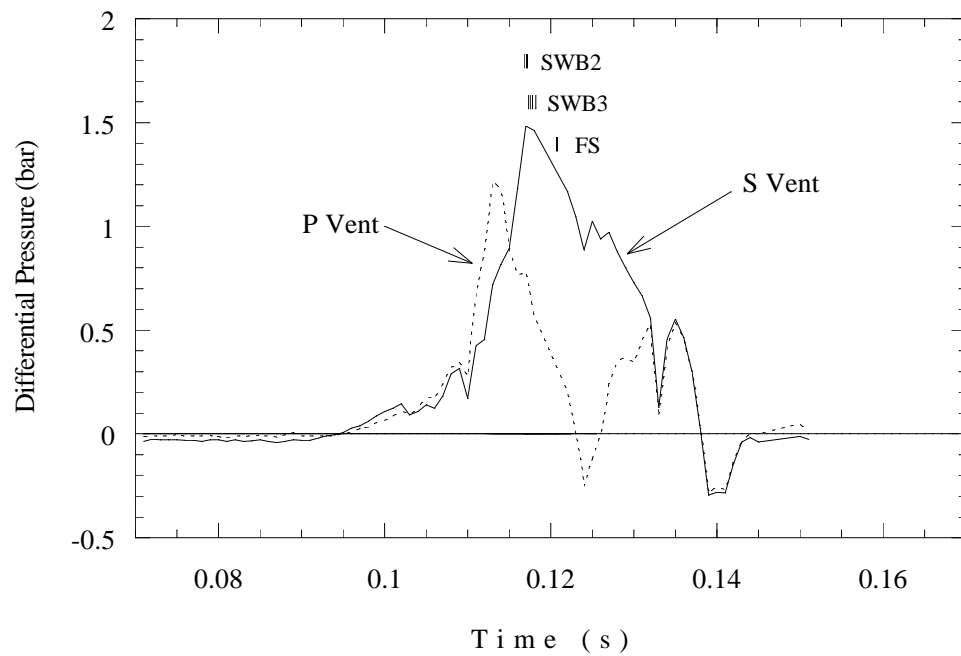
Differential pressure across the vents is shown in Fig. 5.118. The port vent differential rapidly decreases at 113 ms when the port side of MS fails and pressure begins to equalize

Figure 5.118: Differential pressure across vents, ignition in bay 2Lo, with a cold liquid Jet A layer. Test 20.

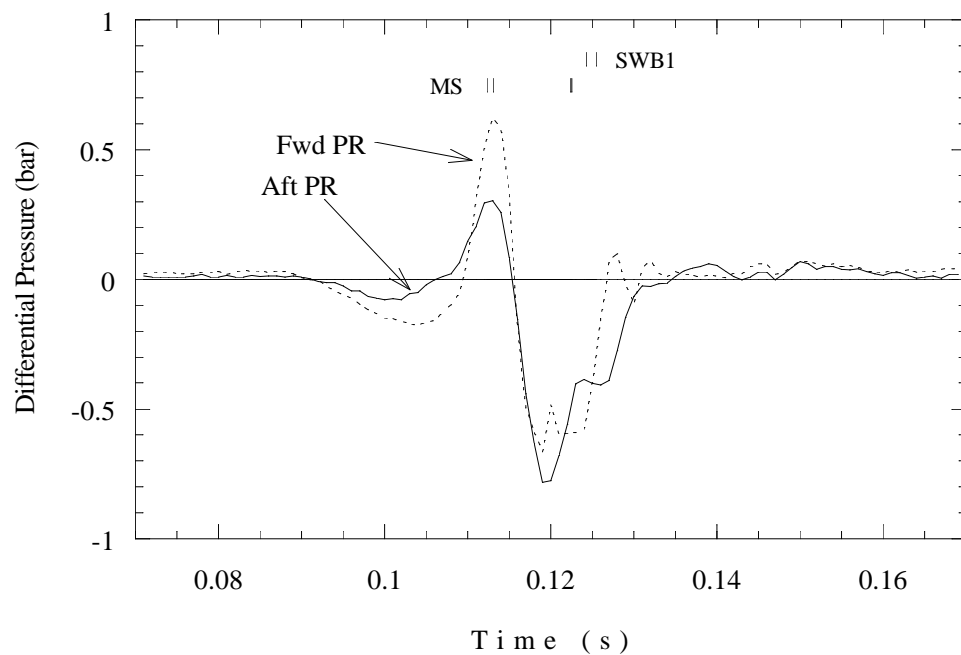
Figure 5.119: Differential pressure across PRs, ignition in bay 2Lo, with a cold liquid Jet A layer. Test 20.

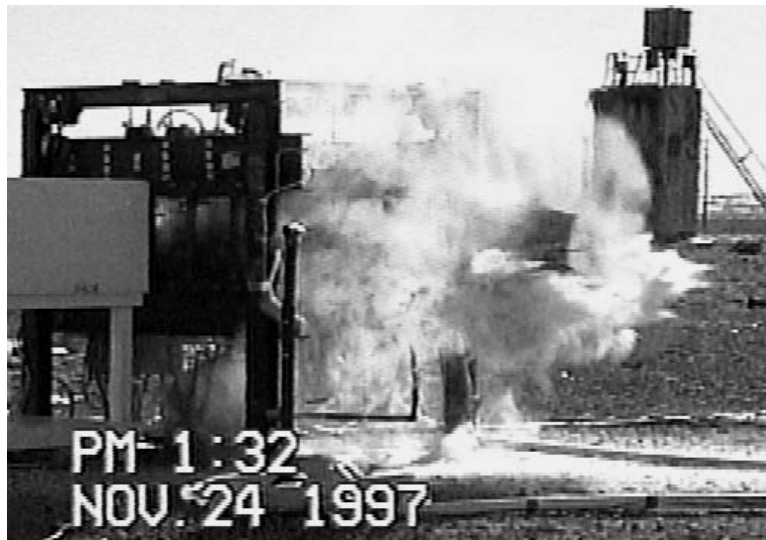
The NE station video camera captured one frame just after the partitions exited the tank. Figure 5.120 shows the three partitions a few feet from the tank, the fireball about to overtake them. In the lead are spray clouds of jet fuel which are overtaken by fire in the next frame. Also visible is an airborne layer of dust along the ground, kicked up by the initial blast wave. This was also picked up by the NE and SE station cameras, but they are zoomed back a bit further and are not as sharp. The higher framing rate does show the flame engulfing the clouds of jet fuel.

Figure 5.120: Frame from SE video camera showing exit of panels surrounded by early fireball and led by jets of liquid fuel. Test 20.

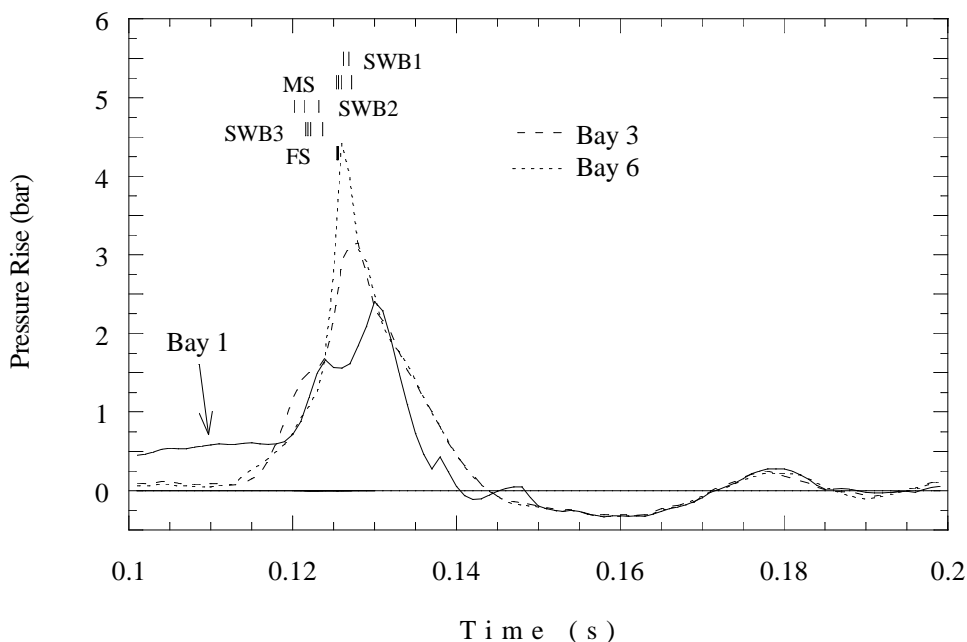
Figure 5.121 shows the pressure traces from bays 1, 3, and 6, covering the ignition location and the bays connected by the vent stringers. We see that bay 1 burns for some time before the aft bays ignite at 115 ms. Bay 1 begins to depressurize as SWB2 and SWB3 fail, but then the pressure continues to increase. This is probably caused by the aft partitions passing through the tank. Pressure piling in the aft bays is also shown in Fig. 5.121, as we see that bays 3 and 6 reach pressures of 3.2 and 4.5 bar, respectively. These bays can reach higher pressures because pressure in the forward bays supports the MS and SWB1 partitions. Bays 3 and 6 vent upon the failure of SWB1, MS, and FS.

Figure 5.121: Pressure traces from bays 1, 3, 6, ignition in bay 1, with a cold liquid Jet A layer. Test 21.

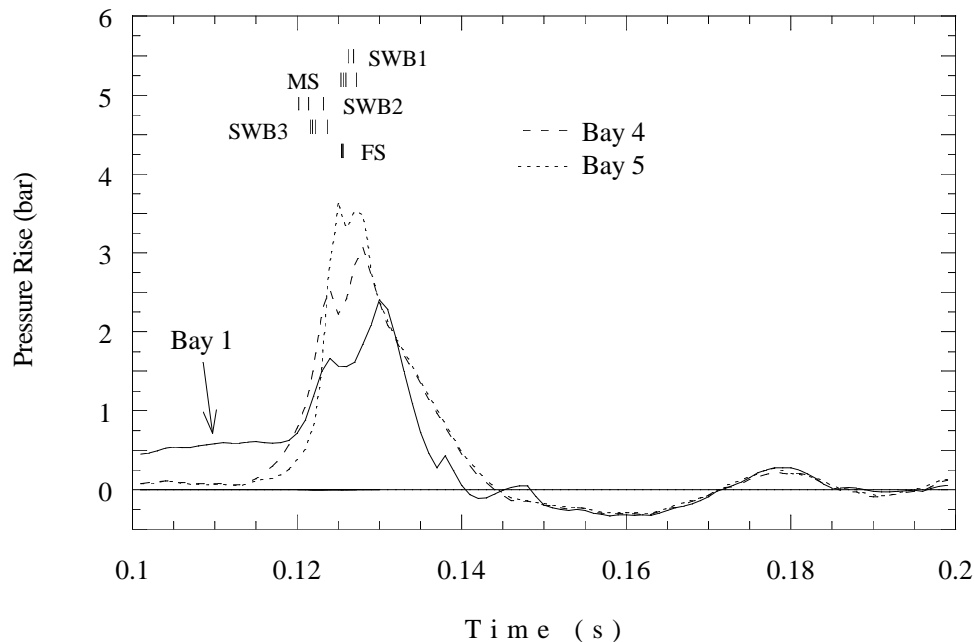
In Fig. 5.122, we see that bays 4 and 5 also ignite at 115 ms. Pressure piling still occurs in the aft bays, but bay 5 only reaches a peak of 3.7 bar. It is unclear why bay 5 does not reach as high a peak pressure as does bay 6. It is interesting to note that all of these traces have similar peak profiles. Bays 4 and 5 follow the same venting profile as bays 3 and 6, maintaining pressure for a short period after partition failure because the aft partitions, torn loose, are still

Figure 5.122: Pressure traces from bays 1, 4, 5, ignition in bay 1, with a cold liquid Jet A layer. Test 21.

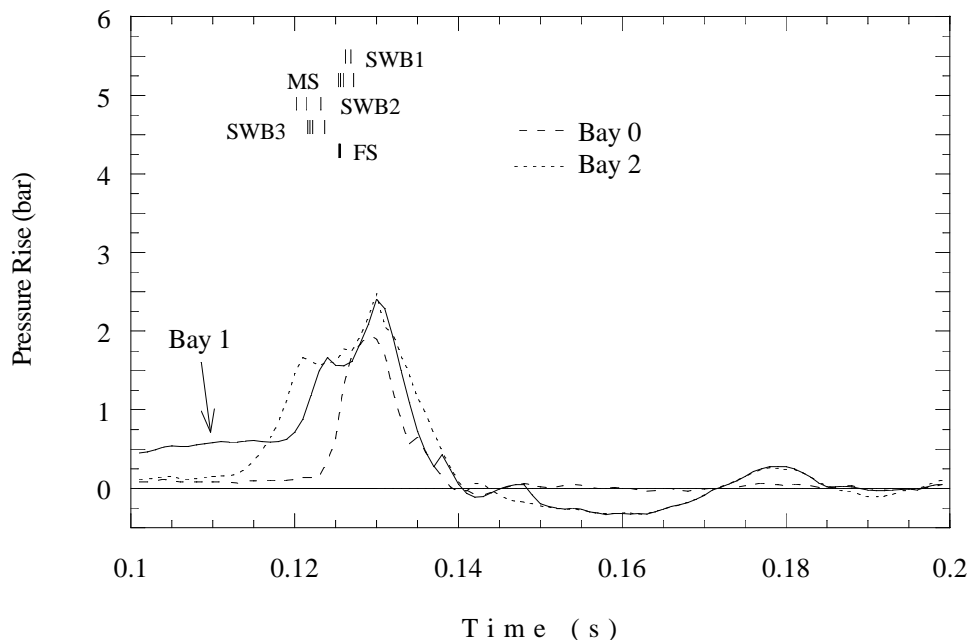
The forward bay pressures are shown in Fig. 5.123. Bay 2 ignites about 2.5 ms before the aft bays ignite. Bay 2 burns rapidly on ignition, the pressure quickly surpassing that of bay 1. Bay 1 transitions to rapid combustion shortly after the onset of rapid combustion in bay 2. Bay 0 pressurizes upon the failure of SWB3, but pressure continues to increase for a short time after the failure of FS. There is a much longer negative pressure phase in this test than in the others with some oscillations in the tail of the signal. This is not registered by the bay 0 transducer because of its proximity to the open end of the tank.

Figure 5.123: Pressure traces from bays 0 – 2, ignition in bay 1, with a cold liquid Jet A layer. Test 21.

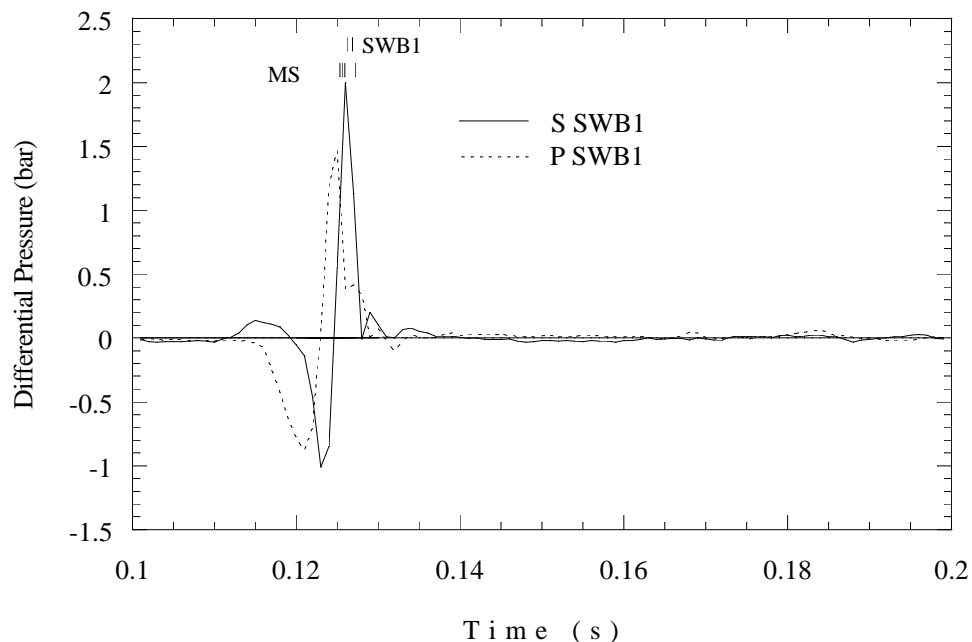
Differential pressures across the aft partitions, SWB1 and MS, are shown in Figs. 5.124 and 5.125, respectively. Differential pressures across SWB1 indicate combustion proceeding from bay 3 to 4 followed by rapid combustion in bays 5 and 6. When SWB1 fails, the pressure differential drops to zero. The port side pressure difference decreases first, although the motion detector data shows nearly simultaneous failure of the top of the SWB1. It is possible that early failure occurred on the bottom, where no detectors were installed. The differentials on MS follow the same pattern. The late peak at 140 ms is probably due to SWB1 passing by on its way out of the tank.

Figure 5.124: Differential pressure across SWB1, ignition in bay 1, with a cold liquid Jet A layer. Test 21.

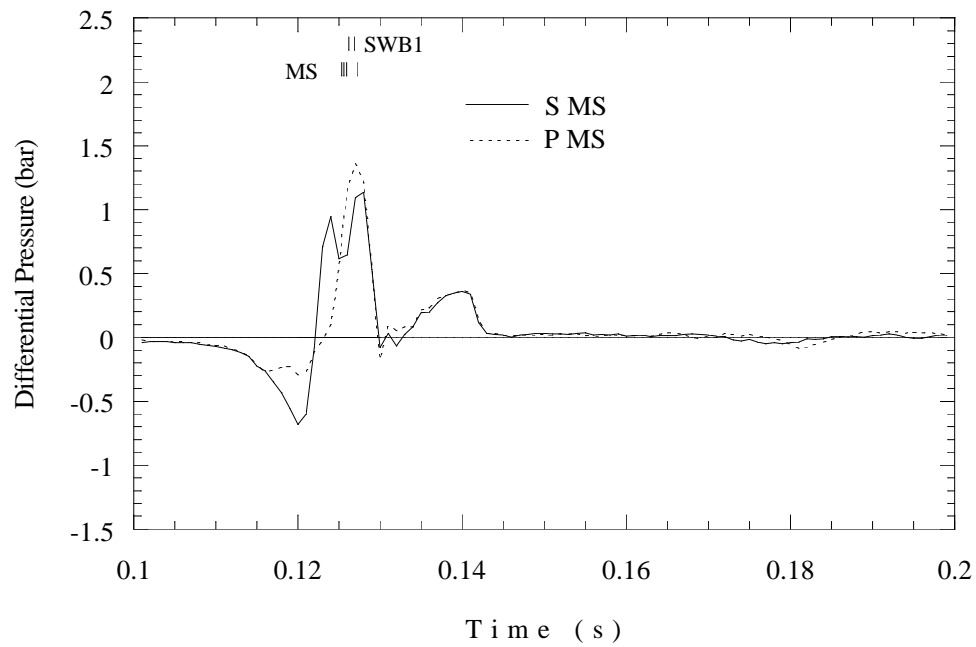
Figure 5.125: Differential pressure across MS, ignition in bay 1, with a cold liquid Jet A layer. Test 21.

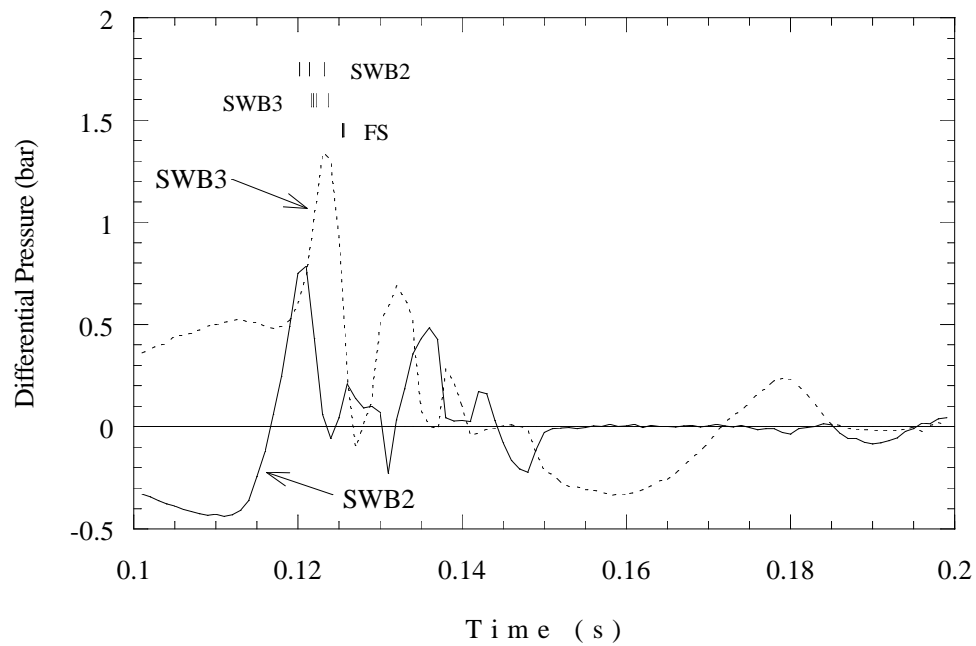
The differential pressures on SWB2 and SWB3 are shown in Fig. 5.126. SWB2 initially experiences a rearward force from the combustion in bay 1, with a maximum amplitude of 0.4 bar. The films indicated that the bottom of SWB2 failed rearward first, which implies a very low failure pressure compared to the design value. As combustion is accelerated in bay 2, with possible contributions from liquid fuel lofting, the direction of force on SWB2 reverses and it fails in the forward direction in the same time frame as does SWB3. SWB3, being the initial

tank boundary and adjacent to the ignition location, always experiences a positive pressure difference until failure of SWB3. In this test, the pressure difference was over 1.3 bar before complete failure of SWB3 occurred. The two subsequent peaks probably indicate passage of aft partitions through the SWB3 location.

Figure 5.126: Differential pressure across SWB2 and SWB3, ignition in bay 1, with a cold liquid Jet A layer. Test 21.

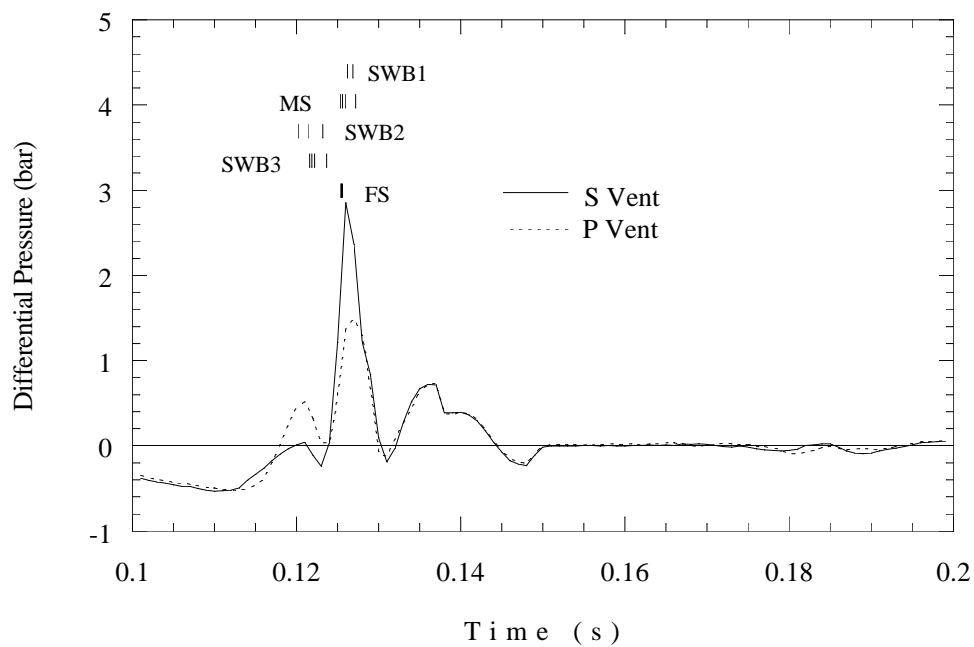
Interpretation of the pressure differentials across the vents (Fig. 5.127) is straightforward. Combustion in bay 1 drives flow aft, with ignition and rapid combustion in the aft bays reversing the flow later on. The higher peak on the starboard vent reflects the higher peak pressure in bay 6. It is interesting that both vents show a secondary pulse after dropping to zero; no panel can pass the starboard vent, as it is in the aftmost bay. Possibly, combustion continues while the panels are vented, and after SWB1 and MS get caught within the tank, the blockage created by these panels creates a pressure differential across the vents.

Figure 5.127: Differential pressure across vents, ignition in bay 1, with a cold liquid Jet A layer. Test 21.

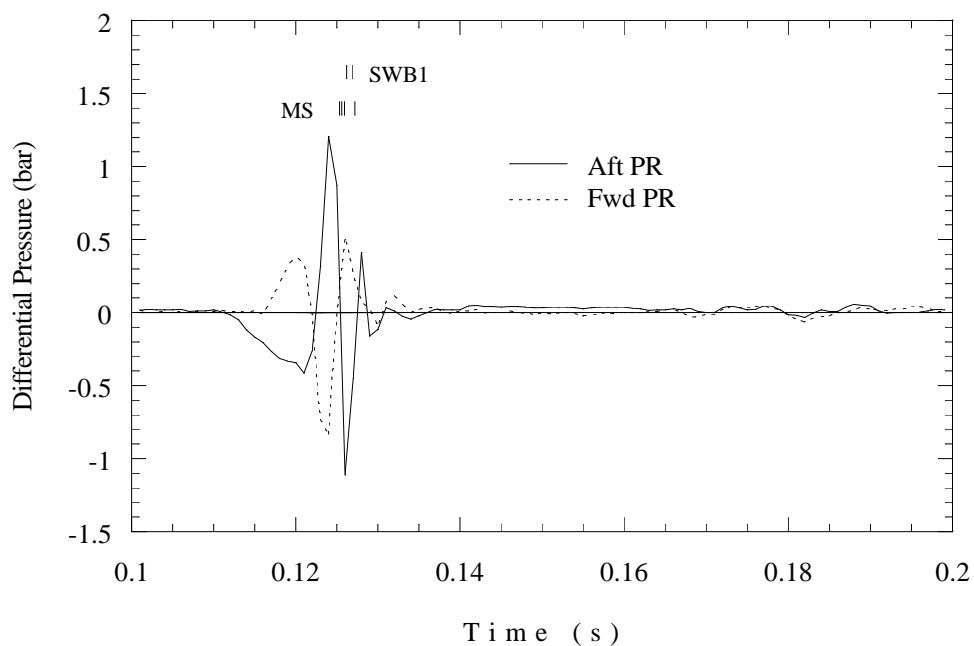
The PR differentials, Fig. 5.128, show evidence of anti-symmetric combustion in the aft bays. The diagonal location of the vent stringers may contribute to this by providing anti-symmetric ignition locations.

Figure 5.128: Differential pressure across PRs, ignition in bay 1, with a cold liquid Jet A layer. Test 21.

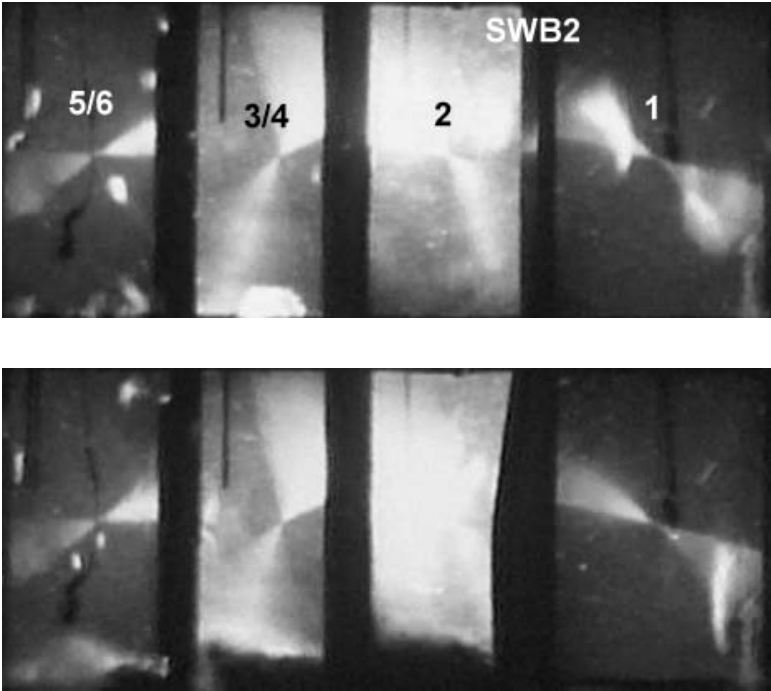
Figure 5.129: Lofting toward rear of fuel with ignition in bay 1 (Test 21). First frame is before ignition for reference. Note that SWB2 is failing rearward in second frame, accompanied by fuel lofting to the rear, indicated by the dark fan-like regions at the bottom surface.

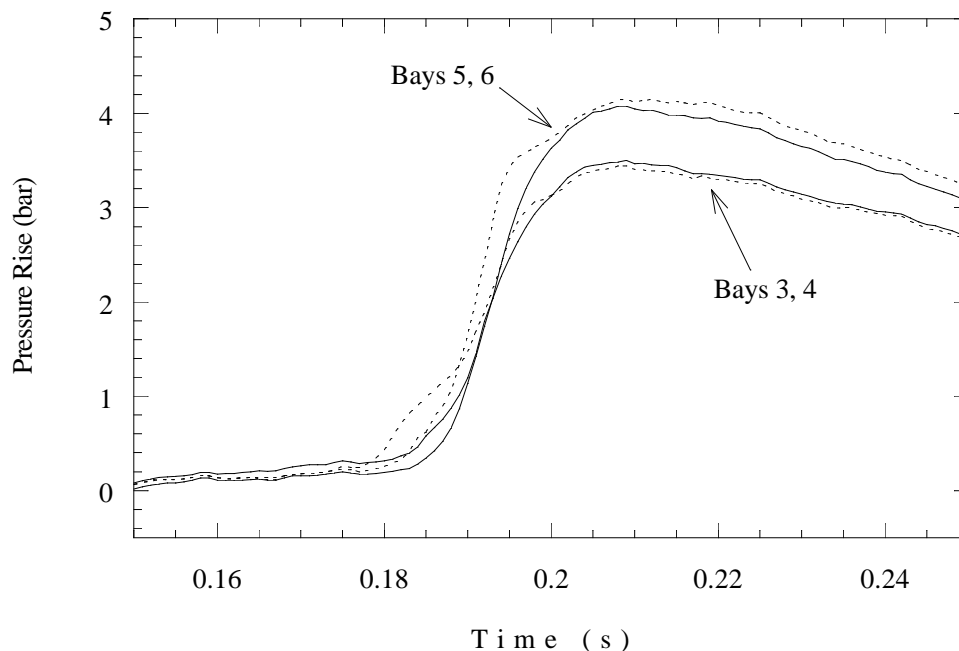
Pressure traces are shown in Figs. 5.130 – 5.135. The pressure traces in the aft bays (Fig. 5.130) exhibit lateral symmetry. Pressure piling occurs as the flame progresses from the front to the back. Bay 4 is the first aft bay to ignite, while bay 5 is the last aft bay to ignite. Bays 3 and 6 appear to ignite at the same time, but bay 6 burns faster. Figure 5.131 shows pressure traces from all of the forward bays, and also bays 3 and 5 (representing the aft bays). It appears that bays 2 and 1 ignite and accelerate at the same time. As bay 1 reaches about 1 bar, SWB3 begins to fail. Pressure in bay 1 dips and recovers as bay 0 (trace under bay 1) begins to pressurize, but FS then fails, and both bays vent. Rupture of the MP was not recorded, but probably occurred near 205 ms, when the pressure in bay 2 begins to drop.

Figure 5.130: Pressure traces for bays 3 – 6, 8.4% fuel, ignition in 2Lo. Dashed lines indicate even-numbered bays. Early liftoff is in bay 4, late liftoff is in bay 5. Test 22.

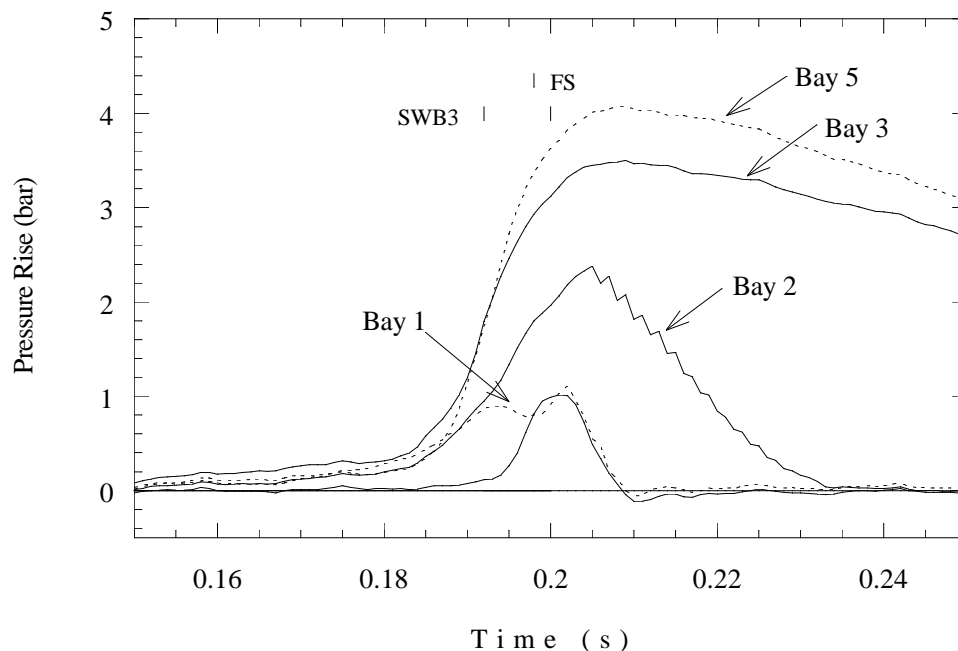
Figure 5.131: Pressure traces for bays 1 – 3, 5, 8.4% fuel. Test 22.

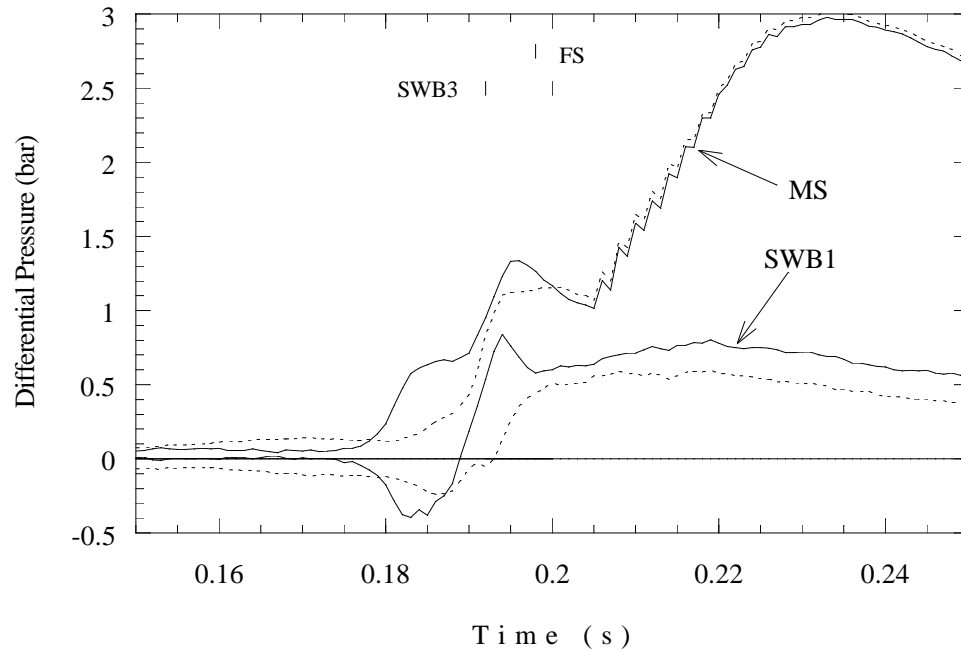
Differential pressures across SWB1 and MS are shown in Fig. 5.132. The transition to rapid combustion can be observed in the starboard differentials at around 180 ms. At 205 ms, the pressure differential on MS rises when the rupture of the MP allows bay 2 to rapidly vent.

Figure 5.132: Differential pressure across SWB1 and MS, 8.4% fuel. Dashed lines for port side, solid lines for starboard. Test 22.

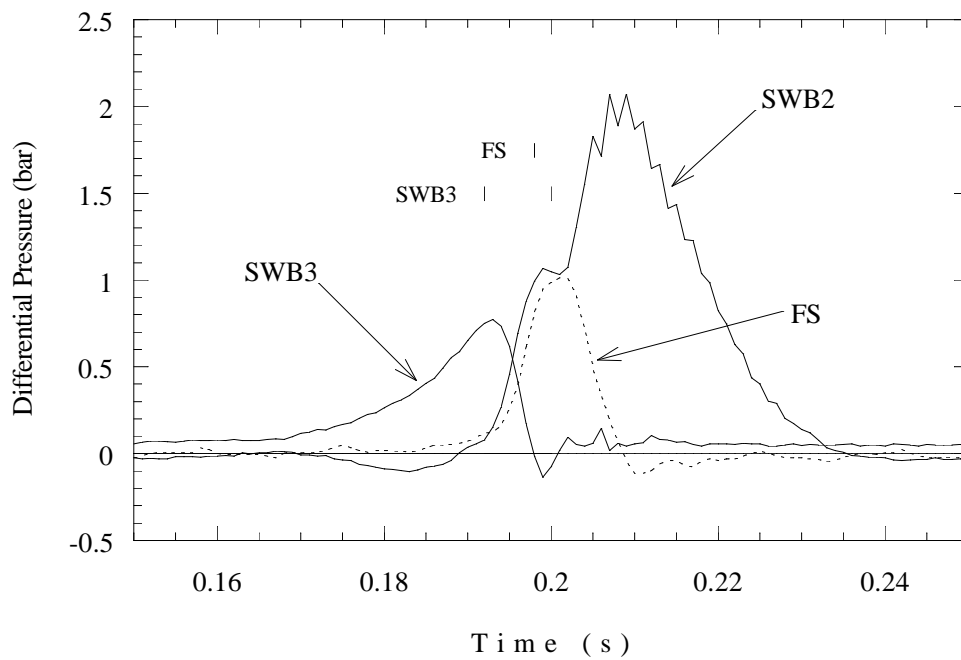
Differentials across the forward partitions are shown in Fig. 5.133. SWB3 is the first partition to experience a forward force, with FS following after SWB3 fails. As bay 1 vents into bay 0, this also causes a pressure difference across SWB2. Once FS fails, the pressure across SWB2 jumps, and MP fails at just under 2 bar. Rapid venting of bay 2 through the MP opening occurs after 210 ms.

Figure 5.133: Differential pressures across SWB2, SWB3, and FS, 8.4% fuel. Test 22.

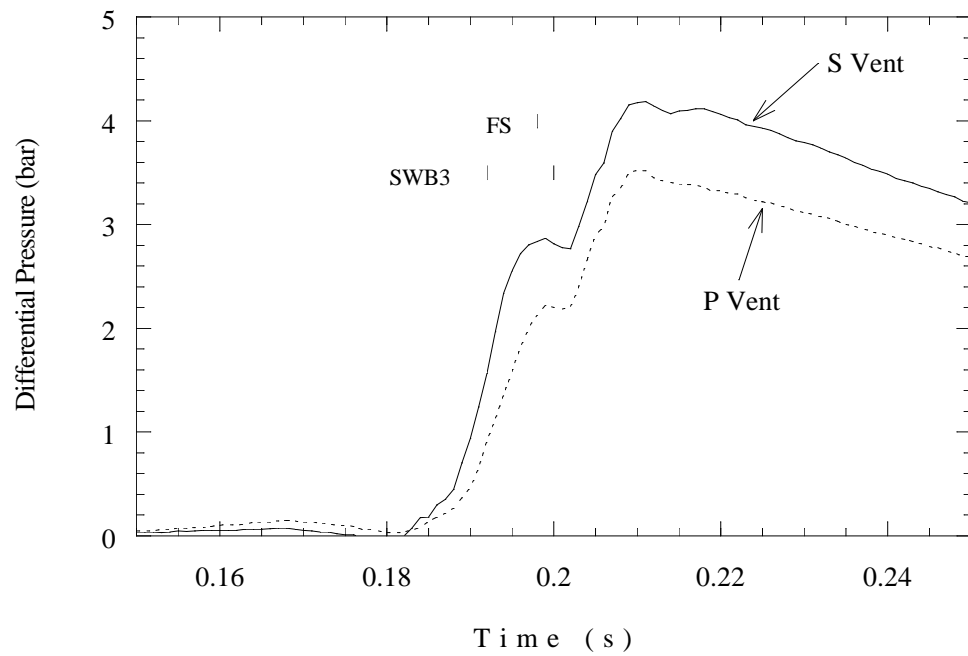
The vent stringer pressure differences are shown in Fig. 5.134. Bays 3 and 6 ignite at nearly the same time, but bay 6 has a greater rate of pressure rise, and this is reflected in the vent differentials (port vent connects to bay 3, starboard to bay 6). When SWB3 and FS fail, there is a dip in the pressure differential. Once both partitions fail and the forward bays vent, the vent pressure differentials reach maximum values.

Figure 5.134: Differential pressure across vents, 8.4% fuel. Test 22.

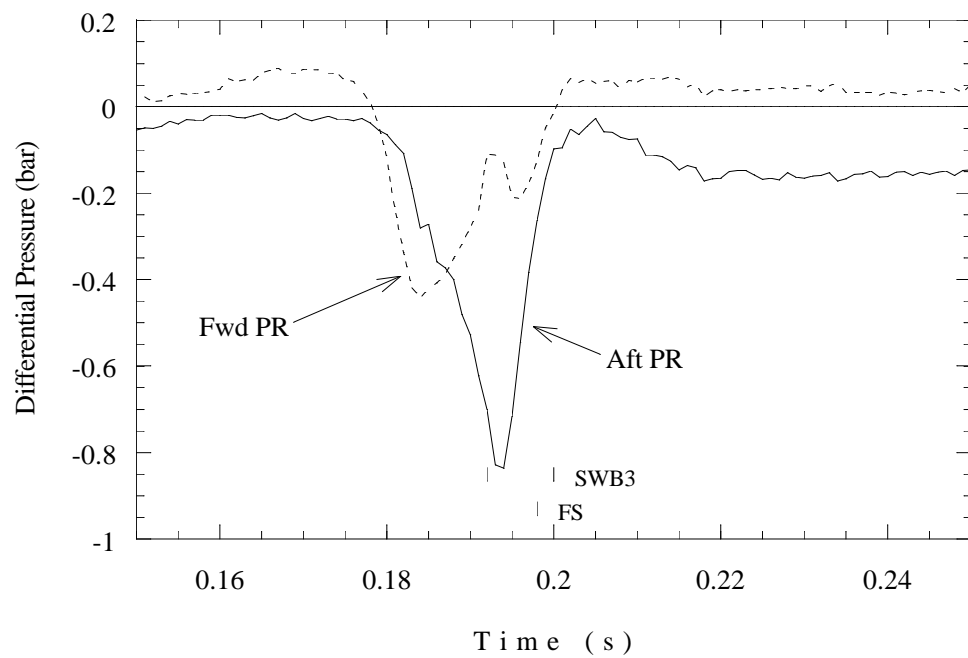
The PR pressure differentials are modest as shown in Fig. 5.135. The rapid combustion in bay 6 results in the negative peak across the aft PR. Likewise, bay 4 has rapid burn, resulting in a negative pressure differential on the forward PR.

Figure 5.135: Differential pressure across PRs, 8.4% fuel. Test 22.

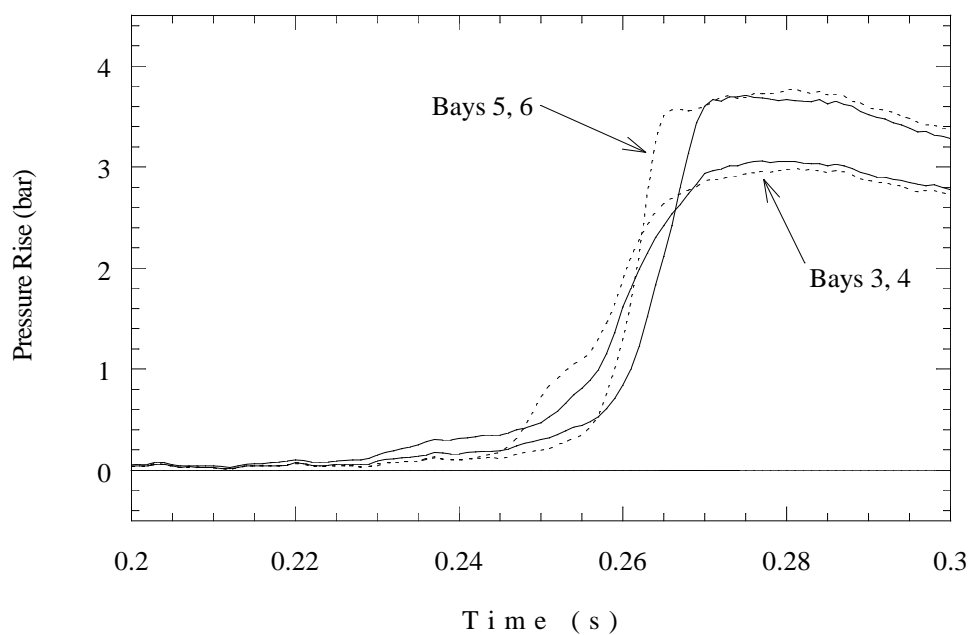
Pressure traces for this test are shown in Figs. 5.136 – 5.141. Pressure traces from the aft bays are similar to those of Test 22 (see Fig. 5.130). In Fig. 5.136, we see that bay 3 shows the earliest ignition, though bay 4 undergoes turbulent combustion at 245 ms and overtakes bay 3 briefly before the traces coalesce. Bay 6 burns at a slightly faster rate than bay 5.

Figure 5.136: Pressure traces for bays 3 – 6, 7.5% fuel. Dashed lines indicate even-numbered bays. Test 23.

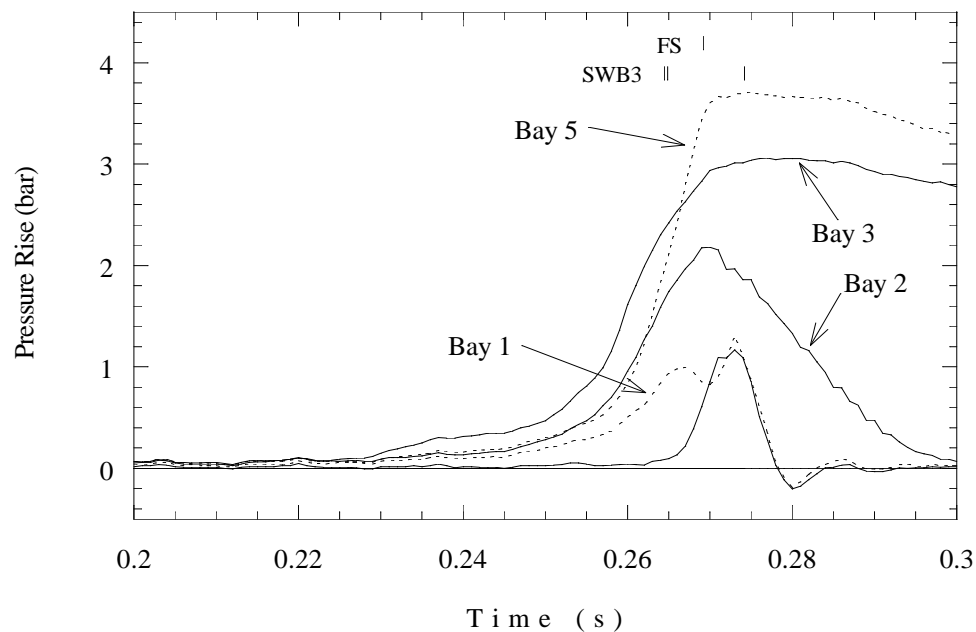
In the forward bays (Fig. 5.136), a pattern similar to that of Test 22 is seen, but bay 1 takes longer to ignite. When the bay 1 pressure reaches about 1 bar, SWB3 begins to fail. The FS fails at about 270 ms, prior to SWB3 completely failing.

Figure 5.137: Pressure traces for bays 0 – 3, 5, 7.5% fuel. Bay 0 trace lies under that of bay 1. Test 23.

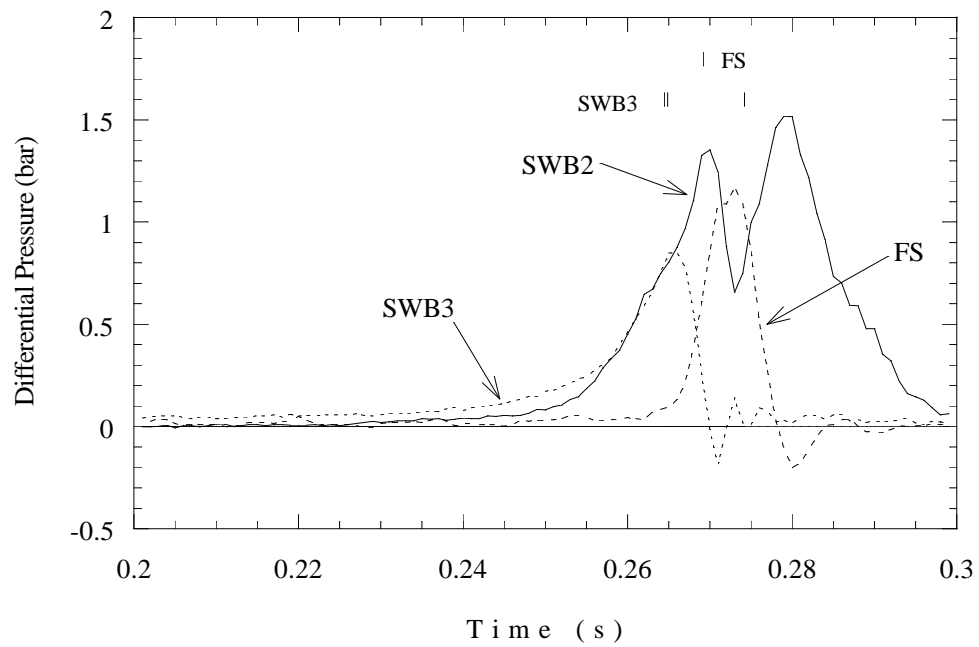
Figure 5.140: Differential pressure across SWB1, SWB2, and FS, 7.5% fuel. Test 23.

The differential pressure across SWB2 in Fig. 5.140 shows an unusual double peak. This is caused by a late peak in the bay 1 pressure, immediately before the failure of FS. Once FS fails, the differential across SWB2 reaches its maximum value.

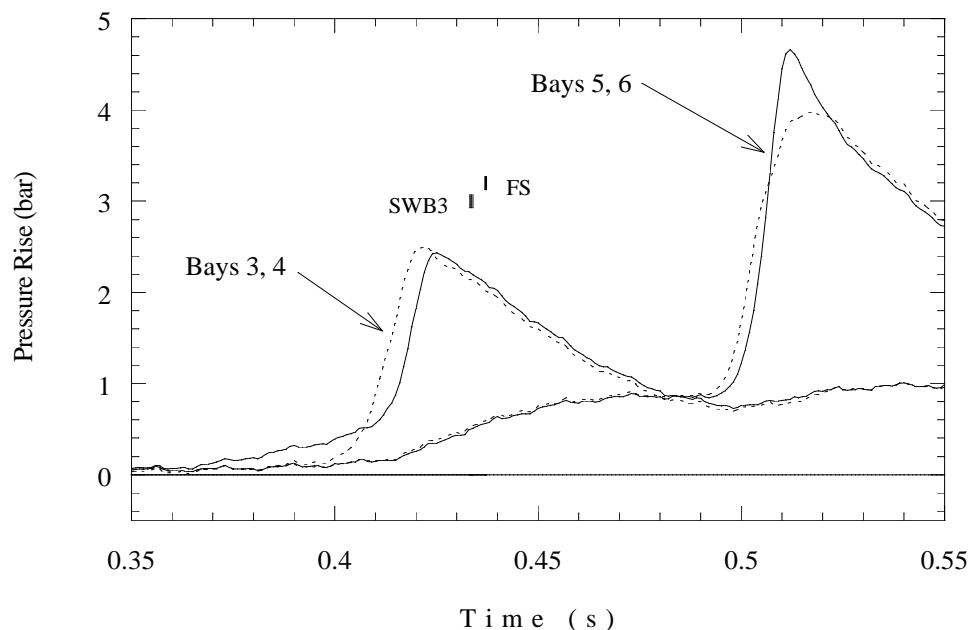
Figure 5.142: Pressure traces from bays 3 – 6, 6.5% fuel. Dashed lines indicate even-numbered bays. Trace with early liftoff is from bay 3; that with high peak is from bay 5. Test 24.

The pressure traces (Figs. 5.142 – 5.148) for this test are very different than for any other test in this series. Note that the time scale in these plots covers 200 ms instead of the typical 100 ms. Figure 5.142, the pressure traces from the aft bays, shows that the burn was laterally symmetric. Bay 3 shows the earliest ignition, followed by ignition in bay 4 at 400 ms. At this time, combustion is accelerated in bay 3 and both bays burn at the same rate. Shortly after the first pressure peak at 420 ms, we see that SWB3 and FS fail.

Up until 420 ms, bays 5 and 6 show no sign of combustion, only pressurization from bays 3 and 4. The pressure at the beginning of the burn is about 0.8 bar due to this pressurization. Finally, at 490 ms, bays 5 and 6 ignite and rapid combustion results in a second, higher peak pressure in these bays. Bay 5 reaches a peak about 0.6 bar higher than that of bay 6. Evidence of the late burn in the aft bays is also visible in the video and photographs. Seal leakage occurred on the sides of SWB1, leaving streaks in the windows in bays 3 and 4. This late burn dramatically illustrates the strong dependence of the pressure loading on initial conditions near the lean flammability limit. In Test 26 (all-strong configuration with 6.5% fuel), bays 5 and 6 never ignited. In Test 24, the flame acceleration associated with partition failure may be a significant factor in inducing the late burn. Further testing with low-concentration mixtures is needed to clarify this situation.
