**Results of 1/4-Scale Experiments.**  
**Vapor Simulant And Liquid Jet A Tests**

17 July 1998 **Revised January 28, 2000**  
Explosion Dynamics Laboratory Report FM98-6

*Prepared for and supported by the National Transportation Safety Board*

The National Transportation Safety Board (NTSB) sponsored a testing program associated with the investigation into the TWA Flight 800 accident which occurred in July of 1996. California Institute of Technology (Caltech) and Applied Research Associates, Inc. (ARA) worked together with the NTSB to perform a study of combustion within a 1/4-scale model of a 747-100 Center Wing Tank (CWT). Tests were performed with the model to examine various ignition locations, vapor concentrations, the effect of a liquid fuel layer, and the failure of the internal partitions that represented the beams and spars within the tank.

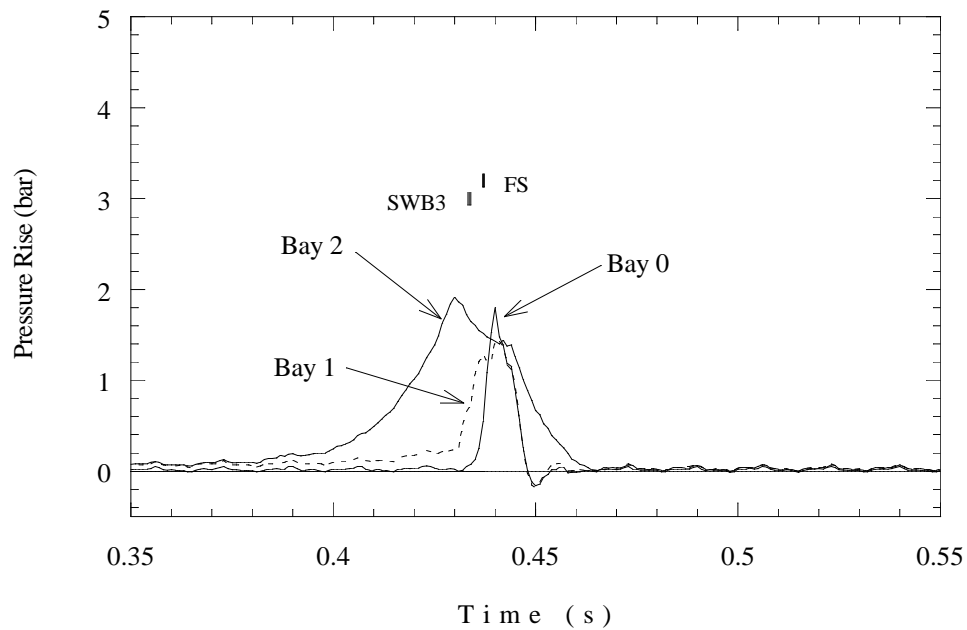
Figure 5.144: Pressure traces from bays 0 – 2, 6.5% fuel. Test 24.

The pressure in bay 0 as compared to that in bays 1 and 2 is shown in Fig. 5.144.. Bay 0 pressurizes rapidly when SWB3 fails and reaches a sharp peak before FS fails as well. Shortly after the bay 0 peak, bay 2 shows a sharp change in pressure drop at 445 ms, accompanied by a kink in the other traces. This probably indicates rupture of the MP.

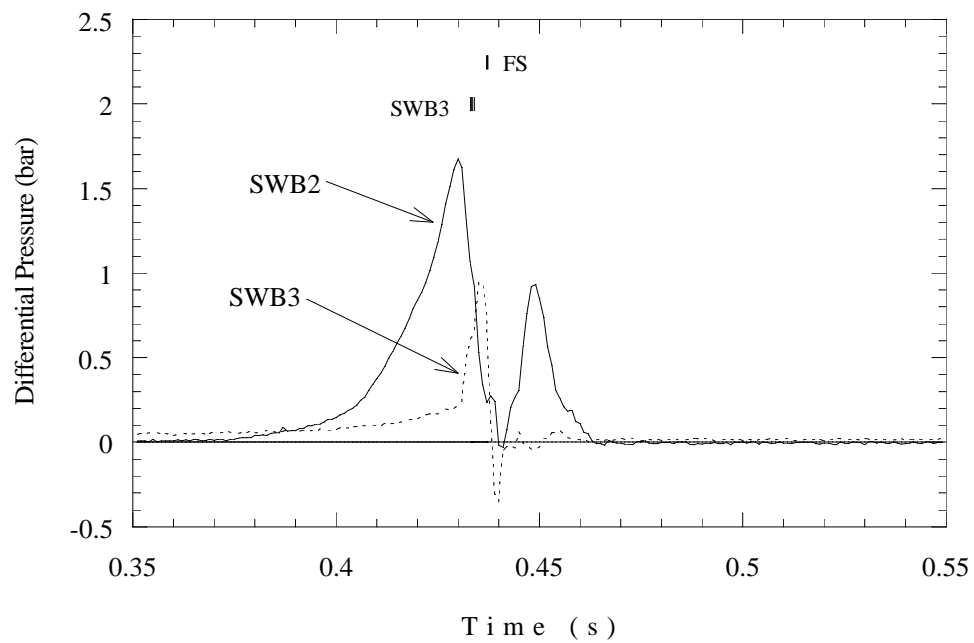
Figure 5.146: Differential pressure across SWB2 and SWB3, 6.5% fuel. Test 24.

Differential pressures across SWB2 and SWB3 are shown in Fig. 5.146. SWB2 has a sharp valley at 440 ms, caused by combustion in bay 1 and pressurization of bay 0. When SWB3 fails, there is sharp negative spike, possibly the result of a reflected shock from the FS. After the partitions have failed, the SWB2 differential again rises and then falls as bay 2 vents.

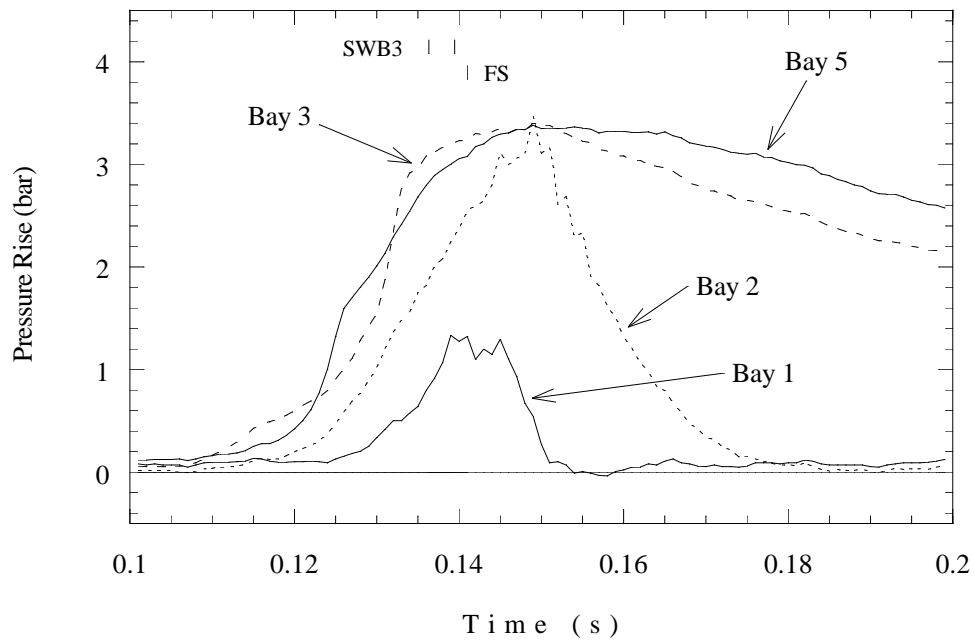
Figure 5.151: Pressure traces from bays 1 – 3, 5, ignition in bay 5. Test 17.

In Fig. 5.151, we see that bays 2 and 1 ignite in sequence. Bay 2 pressurizes at a constant rate until the peak at 150 ms. The MP presumably ruptures near the peak pressure at 150 ms (the breakwire was not used in this test). The pressure in bay 1 continues to rise as SWB3 fails, and drops a short time after FS fails. The pressure in bay 0 is shown in Fig. 5.152, where we see that the pressure overshoots that in bay 1.

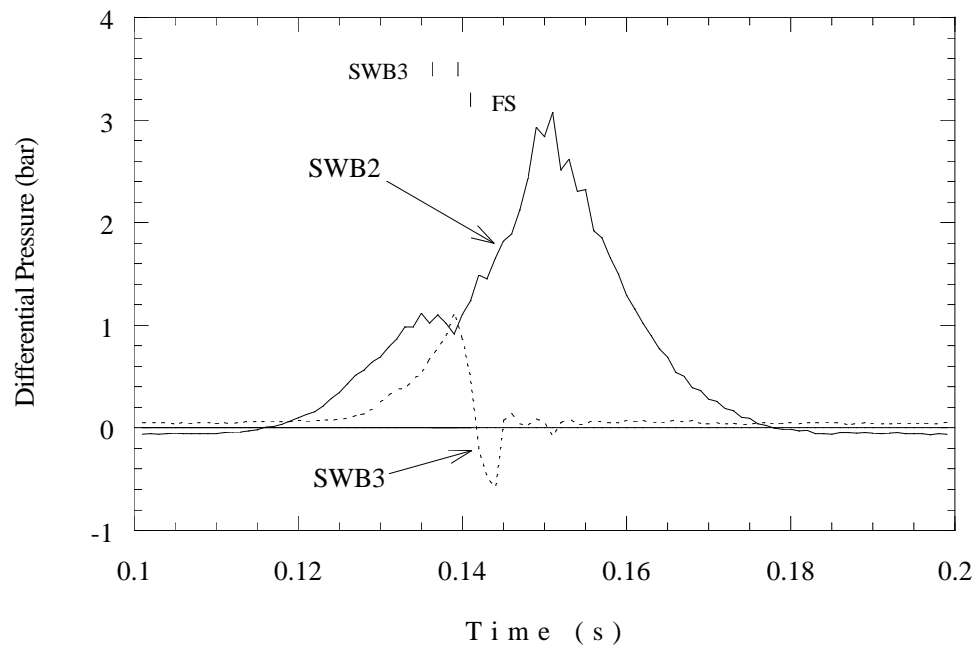
Figure 5.154: Differential pressure across SWB2 and SWB3, ignition in bay 5. Test 17.

Bay 5 ignition produces asymmetrical combustion in the aft bays, as indicated by the differential pressures in Fig. 5.153. The divergence in the port-side traces at 110 ms indicate rapid combustion in bay 3, followed by combustion in bay 4. The differential pressures across SWB2 and SWB3 are shown in Fig. 5.154. The pressure across SWB2 dips when the pressure across SWB3 peaks, but then continues to rise. The MP presumably ruptures when the peak

pressure differential is reached at 150 ms. The SWB3 pressure differential continues to rise as the partition fails and then drops sharply when the last motion detector is tripped.

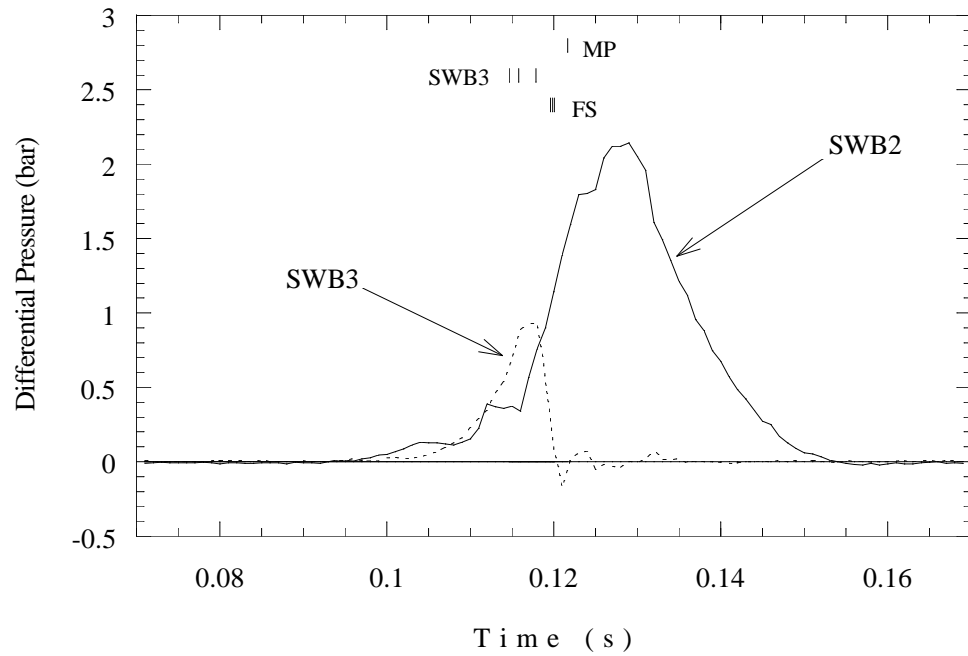
Figure 5.161: Differential pressure across SWB2 and SWB3, ignition in bay 5, layer of cold liquid Jet A. Test 28.

As bay 6 begins to undergo rapid combustion (Fig. 5.160), the transition to a faster burn in bay 4 reverses this trend. The differential pressure on SWB2 (Fig. 5.161) increases rapidly until SWB3 ruptures. This rise is briefly interrupted when the MP ruptures and at 130 ms; venting through the MP begins to lower the pressure in bay 2. The failure of SWB3 takes about 5 ms and occurs at a differential pressure of about 1 bar.

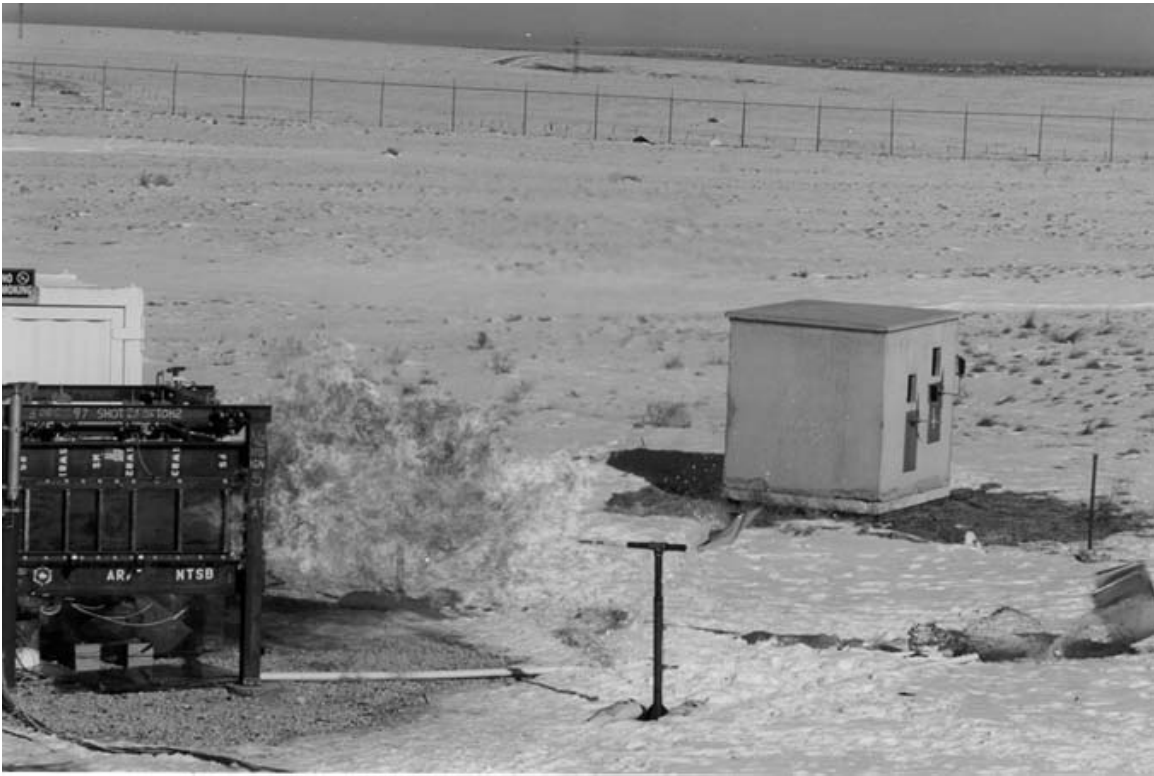
Figure 5.164: Fireball from Test 28 at approximately its greatest extent.

Only the exterior cameras were used in this test. The side-view camera shows jet fuel lofting and burning first in the four aft bays. The jet fuel ignites next in bay 1, where a vertical plume of flame indicates that fuel may be blowing out of the jet fuel manifold. This plume ignited from the top. Fuel in bay 2 was ignited immediately thereafter. SWB3 failed first along the top, and rotated enough that it did not wrap around FS and the water bottles as it exited. The fireball didn't appear to be much bigger than the tank in this test. The fireball is shown in Fig. 5.164, with its growth sequence captured by the 8 fps Nikon in Fig. 5.165. Contrast these to Figs. 5.110 and 5.111 (p. 164 and 165, respectively) to see how the fireball size compares between the part-strong and all-strong configurations.

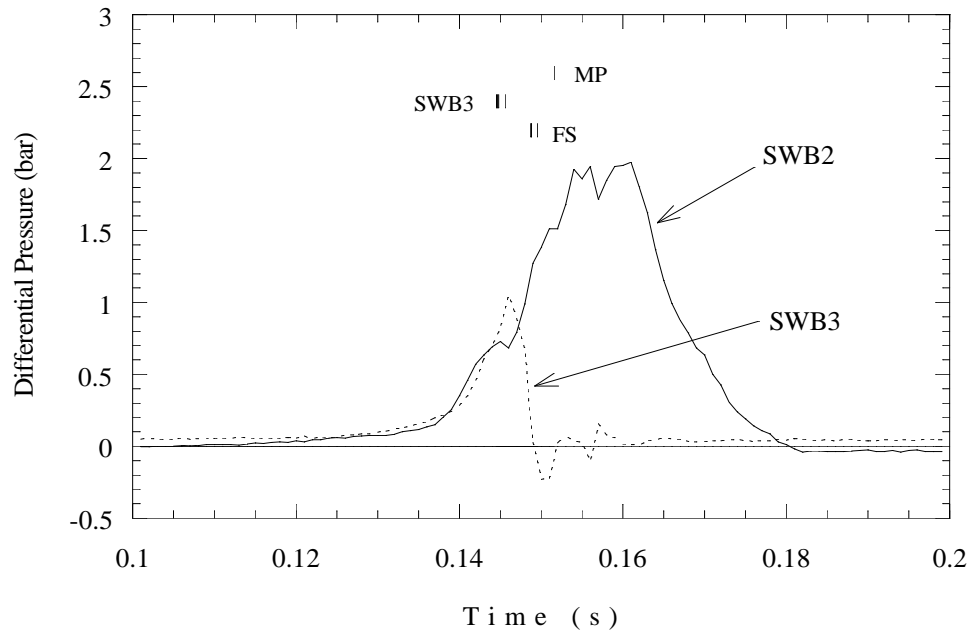
Figure 5.170: Differential pressure across SWB2 and SWB3, ignition in bay 2Lo, cold liquid Jet A layer. Test 27.

In Fig. 5.170, the failure of SWB3 is observed to occur at a pressure difference of about 1 bar. It is interesting to note that bay 2 does not depressurize immediately upon rupture of the MP, but the pressure is maintained for about 10 ms. This may be due to continuing combustion in bay 2 after the MP rupture. The differential pressures on the vents (Fig 5.171) are similar to those observed in other tests.

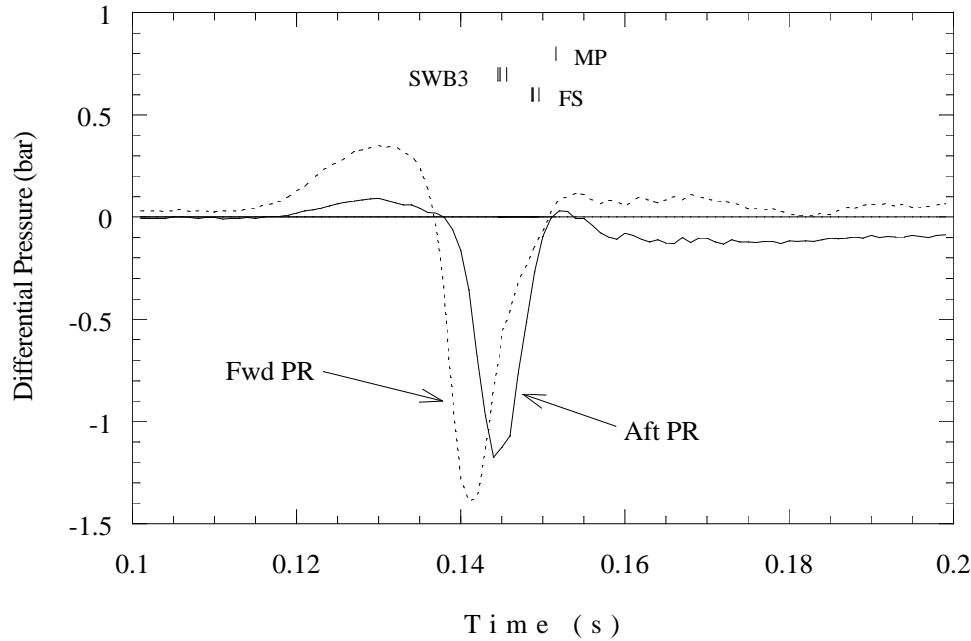
Figure 5.172: Differential pressure across PRs, ignition in bay 2Lo, cold liquid Jet A layer. Test 27.

The pressures across the PRs (Fig. 5.172) again show the asymmetry in this test, which is unusual for ignition in bay 2 (central or 2Lo). The peaks indicate rapid pressure rises in bays 4 and 6, before 3 and 4 can catch up and equalize the pressure. Once the panels fail, the venting serves to equalize pressures, with the slight negative differential pressure on the aft PR due to the connection of bay 6 to bay 1 via the vent stringer.

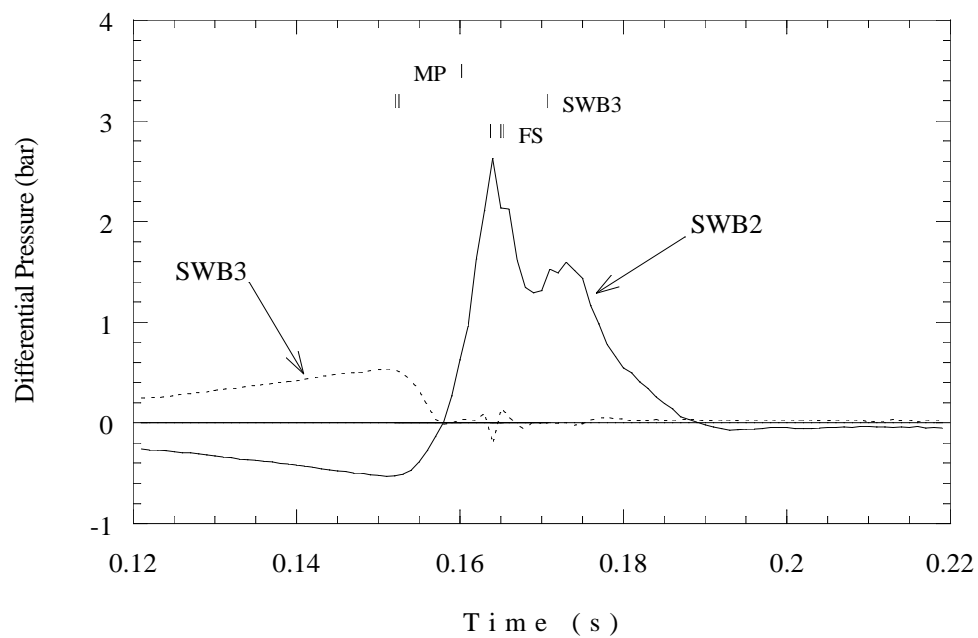
Figure 5.179: Differential pressure across SWB2 and SWB3, ignition in bay 1, cold liquid Jet A layer. Test 29.

In Fig. 5.179, we see that the pressure across SWB2 starts negative as the pressure slowly builds in bay 1. As soon as SWB3 begins to fail, the pressure difference begins to rise and peaks when FS fails. There is a slight kink in the curve when the MP fails. The trace for SWB3 confirms that the partition fails early, since the pressure difference drops to zero at the time of SWB3 failure.

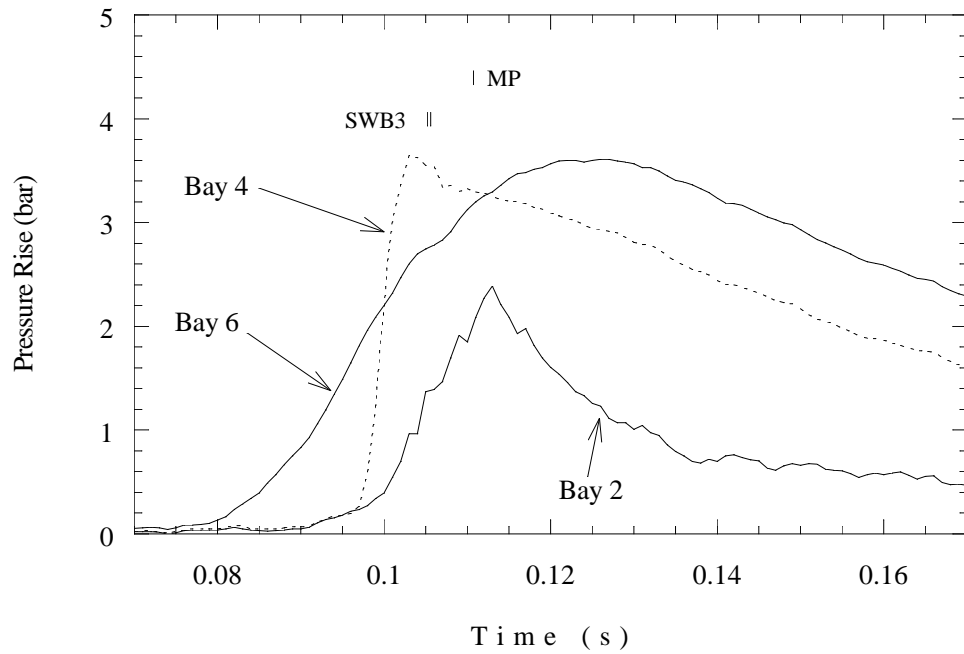
Figure 5.186: Pressure traces from bays 2, 4, 6, cargo bay test. Test 30.

Figure 5.186 shows traces from bays 2, 4, and 6. The pressure traces are typical of bay 5 ignition, with a slow, smooth rise in bay 6, followed by delayed ignition and a sharp jump in bay 4 pressure. Bay 2 reaches a peak of 2.4 bar, while the MP ruptures shortly before this, at about 110 ms. The peak pressure in bay 2 is lower in this test than in Test 28, probably due to the lack of confinement associated with the missing FS.

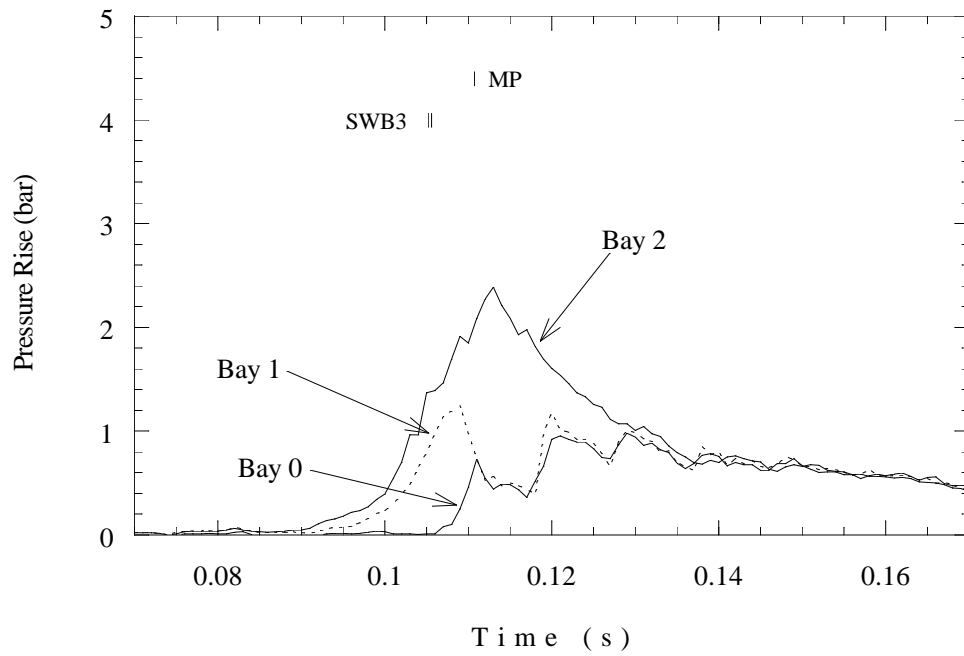
Figure 5.187: Pressure traces from bays 0 – 2, cargo bay test. Test 30.

Pressures from bays 0 and 1 are shown in Fig. 5.187. SWB3 fails at 105 ms, shortly before the pressure in bay 1 reaches a peak of 1.2 – 1.3 bar. Failure of SWB3 results in the pressure traces from bays 1 and 0 coalescing at 110 ms. The rupture of SBW3 sends pressure waves into bay 0 and the model cargo bay. These waves reverberate within the tank and cargo bay, thus pressurizing the cargo bay. In Fig. 5.188, the time and pressure scales have been expanded to show the shockwaves. These waves are not well resolved by the Endevco gauges due to the slow rate of recording and the thermal protection system. Very well-defined shockwaves are visible on the PCB traces. The timing of the pressure pulses indicates that it takes about 6 ms for the waves to travel from bay 0 to the end of the cargo bay, corresponding to the speed of sound in the air, about 330 m/s. The peak pressures on the Endevcos reach 1.3 bar, with an average of about 0.9 bar.

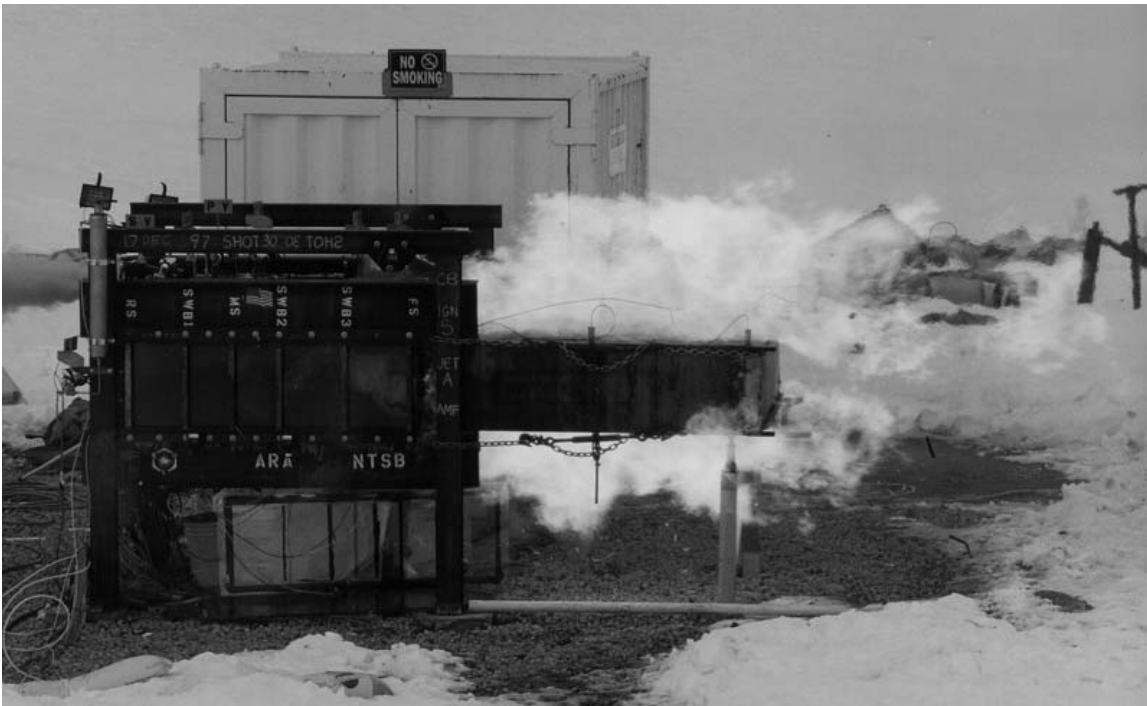
and the tank. A tongue of fire forms under the cargo bay, probably from jet fuel that remained on the floor of the tank and was blown out of the bottom opening. This lower flame turns into a flame jet, and is joined by one of equal strength on the top surface. The flames extend several feet beyond the end of the cargo bay, as seen in Fig. 5.191 (taken by one of the Nikon cameras). Fortunately, the flames were of short duration, and the transducers were in protective housings, so they were not damaged. (The flame jet lasted for less than 2 seconds.) The jet also blows the airborne transducer cables forward.

Figure 5.191: Flame jets exiting gaps created by deformation of top and bottom of cargo bay. Test 30.

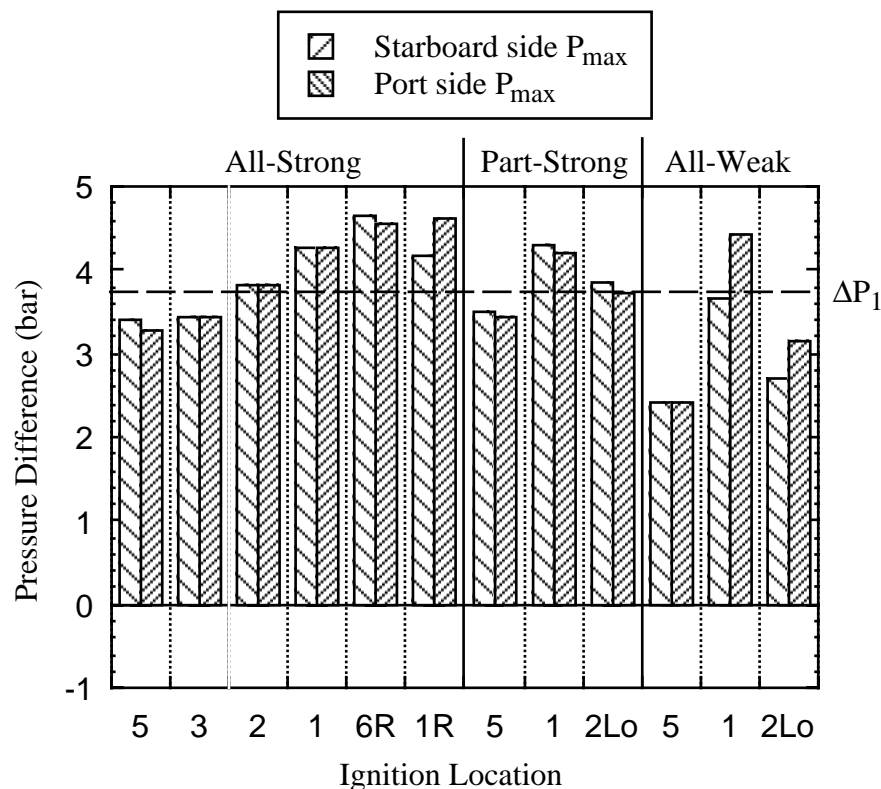
The CWT ullage temperature (Bower 1997) at 14 kft was between 40 and 50°C and the measured (Sagebiel 1997) fuel-air mass ratio was about 0.05, corresponding to a partial pressure of fuel of about 6.5 mbar. The vapor pressure of Jet A (3 kg/m<sup>3</sup>) at 40°C is 6 mbar and at 50°C, 10 mbar (Woodrow and Seiber 1997). This indicates that less fuel should be used to simulate the TWA 800 event than the nominal mixture used in the 1/4-scale tests. If there is less fuel, then the peak pressures may be less than the failure pressure of the RS. Laboratory tests on Jet A vapor indicate that the maximum explosion pressure rise at 40°C is about 3 bar (44 psi). Test 23 (part strong) with 7.5% total fuel had a peak pressure of about 3.7 – 3.8 bar on the RS but there was clear evidence of pressure piling in the aft bays in this test. Test 24 (part strong) with 6.5% total fuel had a peak pressure difference of 4 – 4.7 bar on the rear spar but a very unusual delayed explosion event occurred in this test and there was substantial pressure piling. Test 26 (all strong) with 6.5% total fuel had a peak pressure difference of 1.1 bar. Due to the effects of pressure piling, further testing will be required in order to put an upper bound on the fuel concentration that will not fail the RS.

Figure 9.1: Summary of peak differential pressure on RS for selected tests given in Table 9.1.

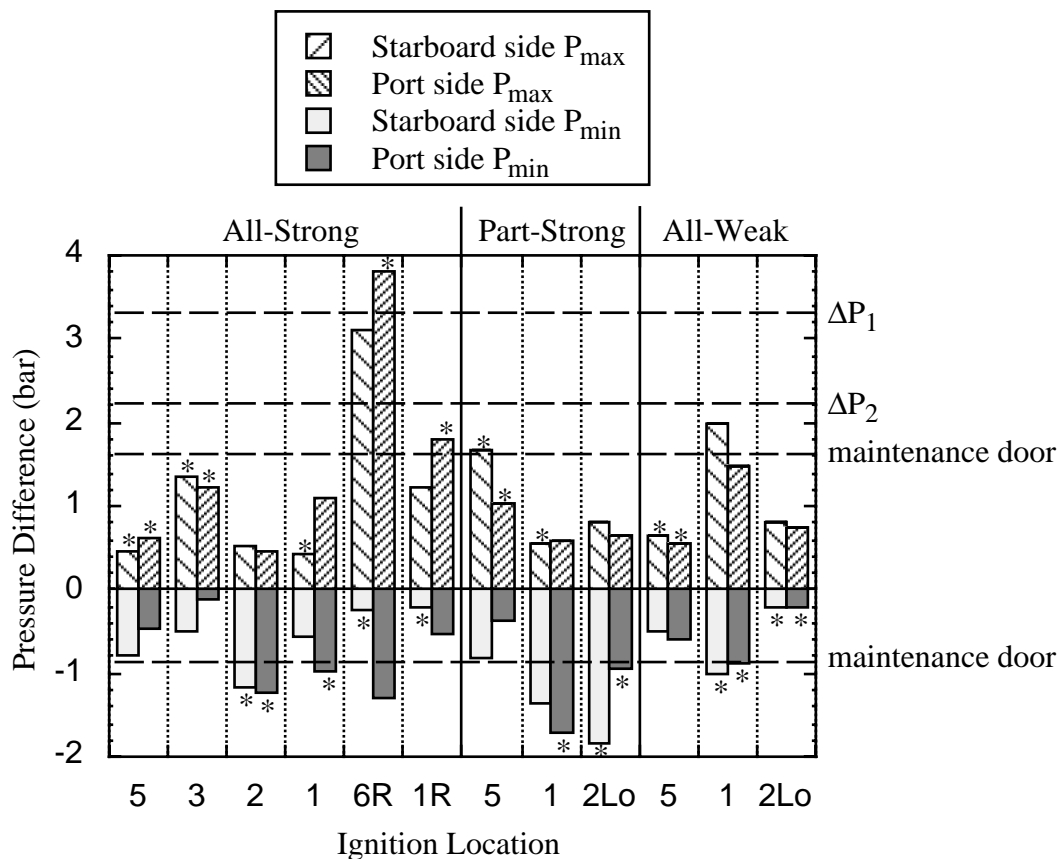
**SWB1** Differential failure pressure for SWB1 is estimated by Boeing to be about 3.3 bar. SWB1 is believed not to have failed due to the initial explosion. The measured peak differential

pressure is substantially less than the failure pressure in all cases except for Test 15, all-strong, ignition in 6R. The maintenance doors would fail in the aft direction in five of the twelve cases examined. The maintenance doors would fail in the forward direction in three cases and there would be no failure at all in four cases. The maintenance doors are believed to have failed in the aft direction as a result of the initial explosion. The force on SWB1 is mixed, i.e., both forward and rearward.

Figure 9.2: Summary of peak differential pressure on SWB1 for selected tests given in Table 9.1. The pressure peak that occurred first is indicated by an asterisk.

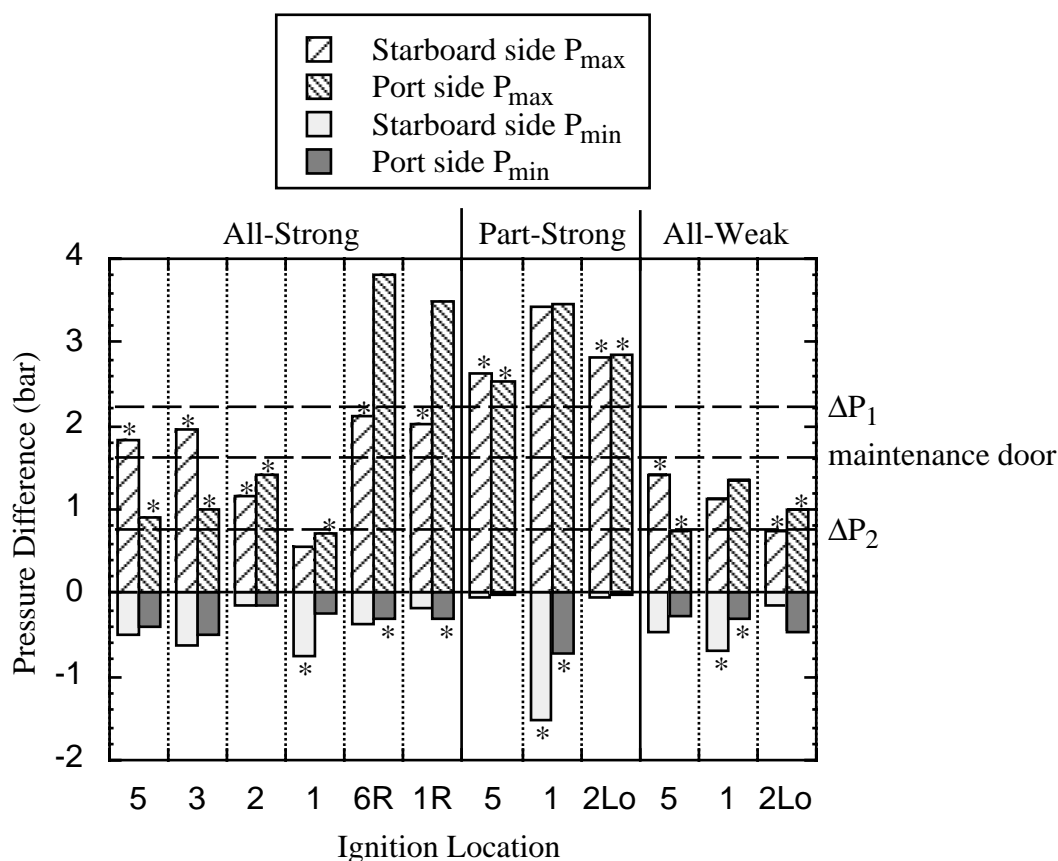
**MS** The failure pressure for the MS is estimated by Boeing to be about 2.2 bar. The observed peak pressures are higher than this in five out of the twelve cases examined. The failure pressure for the maintenance doors is about 1.6 bar (both directions). At least one door would fail forward in nine cases, aft in one case, and no failure in two cases. The doors are believed not to have failed due to the initial explosion. The force on the MS is predominately in the forward direction.

Figure 9.3: Summary of peak differential pressure on the MS for selected tests given in Table 9.1. The pressure peak that occurred first is indicated by an asterisk.

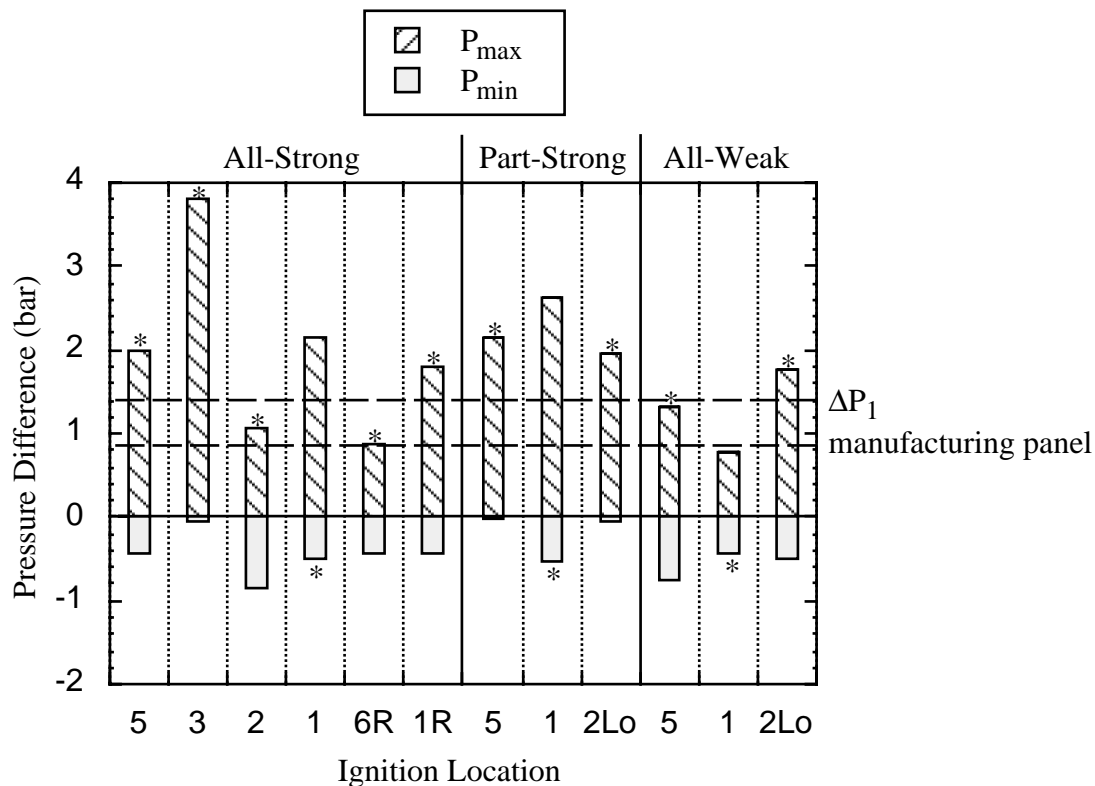
**SWB2** The failure pressure for SWB2 is estimated by Boeing to be about 1.4 bar if SWB3 is intact and 1.3 if SWB3 has failed. The observed peak pressures are higher than failure in eight

out of the twelve cases examined. The status of SWB2 is questionable, but some fraction of it was believed not to have failed due to the initial explosion.

The failure pressure for the maintenance door is about 1.5 bar (forward) and 1.6 bar (aftward). The door would fail forward in eight cases, aft in zero cases, and no failure in four cases. The door is believed not to have failed due to the initial explosion. The manufacturing panel is believed to have failed, but the timing is unclear and this may have occurred later in the event. Boeing estimated a residual strength (after shearing due to keel beam motion) of about 0.82 bar. MP failure would have occurred in eleven out of twelve cases. The force on SWB2 is predominately in the forward direction.

Figure 9.4: Summary of peak differential pressure on SWB2 for selected tests given in Table 9.1. The pressure peak that occurred first is indicated by an asterisk.

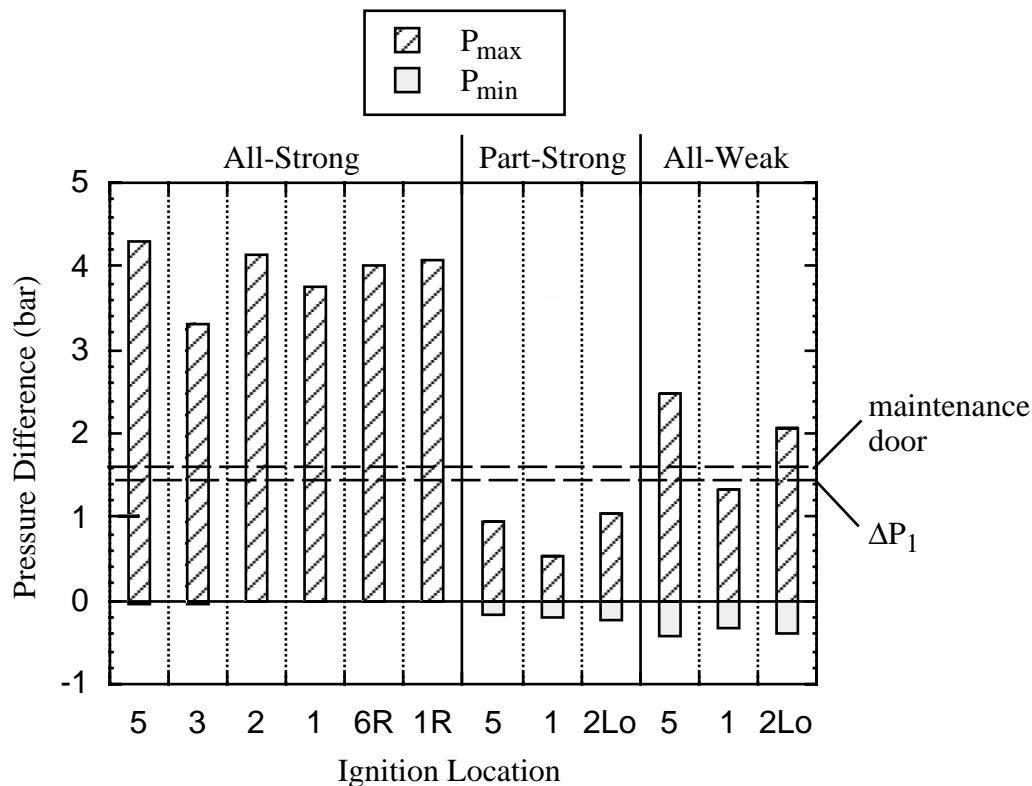
**SWB3** The failure differential pressure of SWB3 is estimated by Boeing to be 1.4 bar. In all tests except those with 6% total fuel, the peak pressure on the front spar exceeded this value by at least a factor of two and in some cases, three. In order to get a lower bound on the fuel concentration that will result in failing SWB3, further tests with parametric variation of fuel concentration are needed.

Figure 9.5: Summary of peak differential pressure on SWB3 for selected tests given in Table 9.1.
